COMPLAINT

**Re: Boca Bridges Homeowners' Association, Inc.
Property Condition Assessment 558 Report**

Boca Bridges - Communities

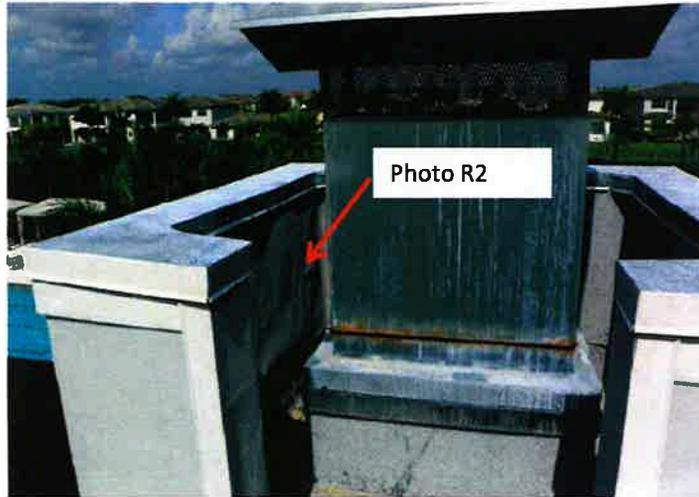
Photo No. R 1

Location: Clubhouse: Roof, Kitchen Vent Enclosure

Remarks: Blister(s).

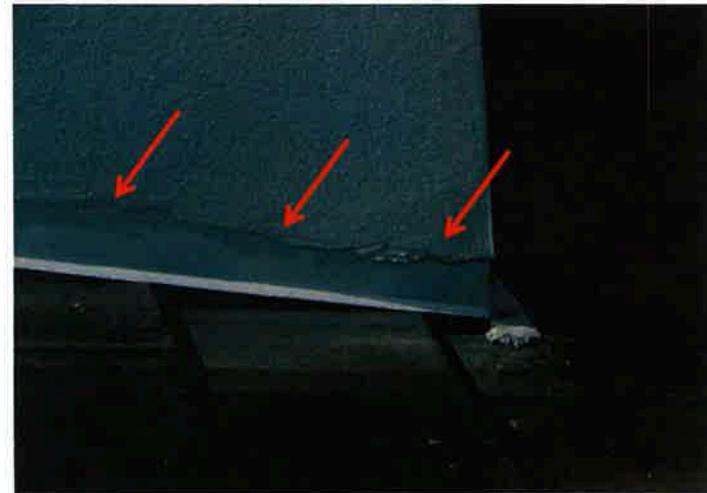
Photo No. R 4

Location: Clubhouse: Roof, Stucco-to-Counterflashing

Remarks: Cementitious material in contact with metal. Crack(s).

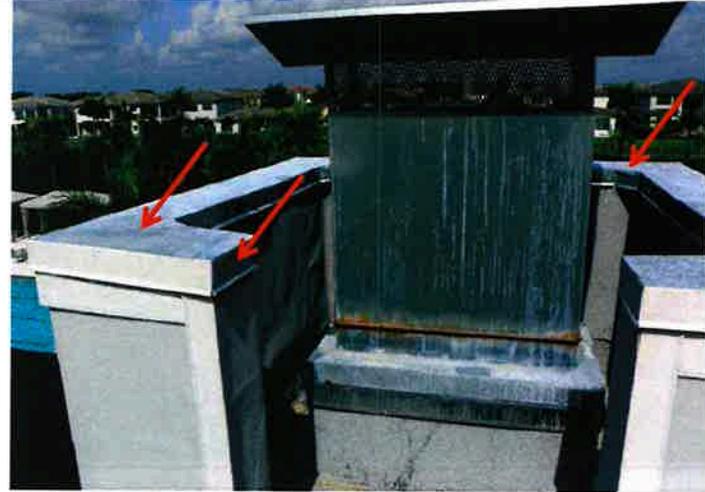
Photo No. R 6

Location: Clubhouse: Roof, Kitchen Vent Enclosure, Parapet Cap

Remarks: Finish is failing. Parapet cap not painted uniformly.

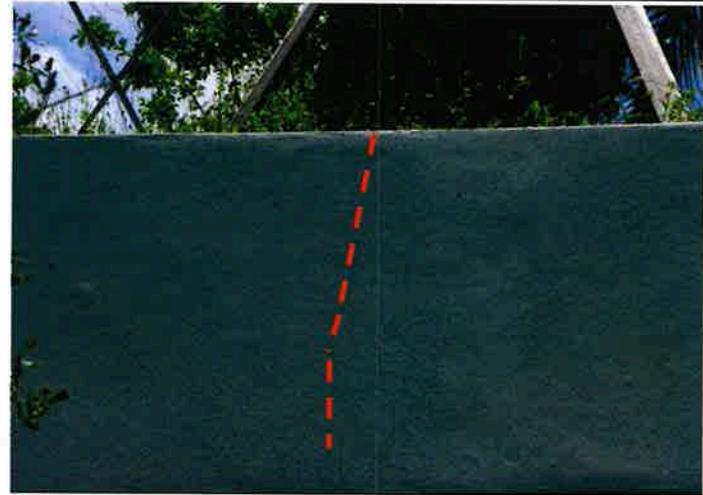
Photo No. ST 2

Location: East Entrance: Back of South Water Feature

Remarks: Crack(s).

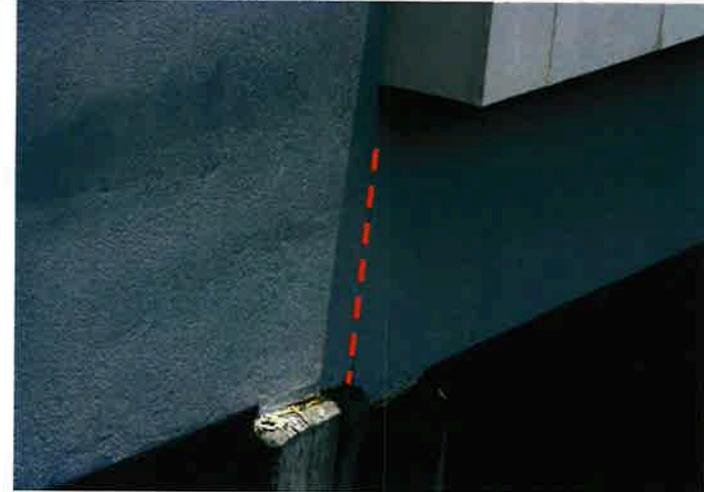
Photo No. ST 10

Location: North Entrance: Bridge

Remarks: Crack(s).

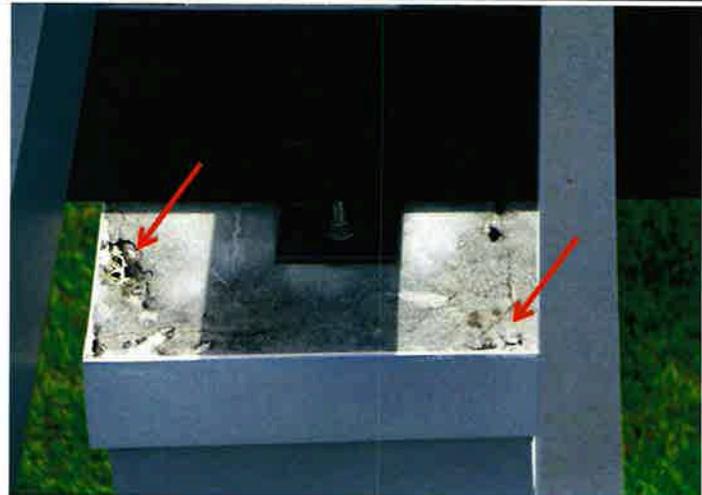
Photo No. ST 20

Location: Clubhouse: West Trellis, Top of Column

Remarks: Crack(s). Spalled, unpainted stucco.

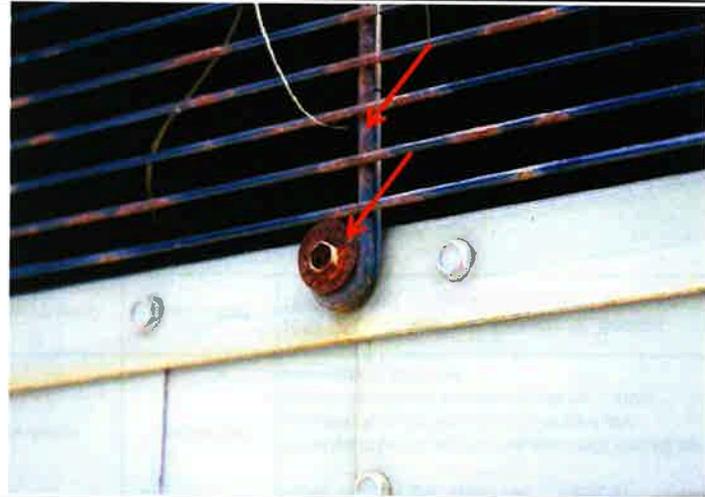
Photo No. ME 2

Location: Equipment Enclosure #2 Near Basketball Court: Outside Air Handling Unit 1 (OAU-1), Screws and Support
Remarks: Signs of finish failure.

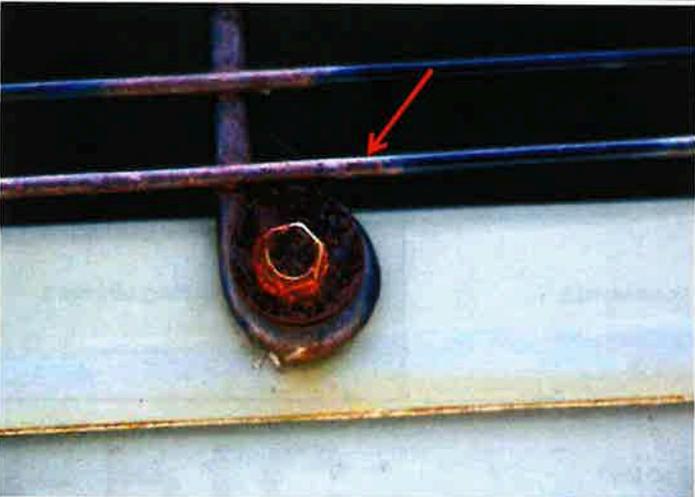
Photo No. ME 3

Location: Equipment Enclosure #2 Near Basketball Court: Outside Air Handling Unit 1 (OAU-1), Screws and Support
Remarks: Signs of finish failure.

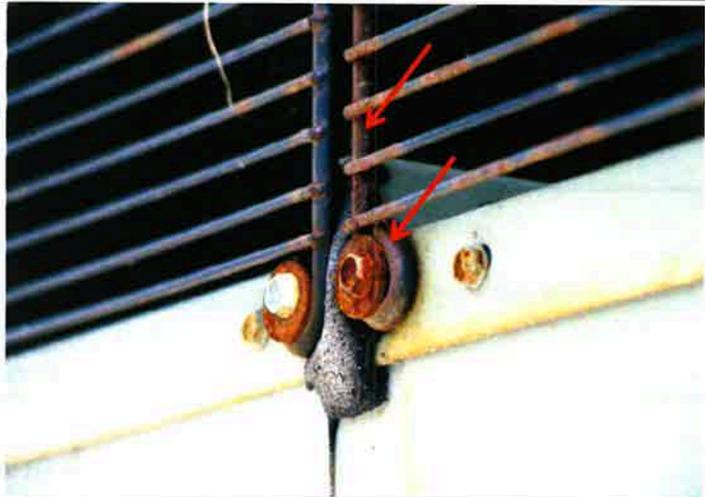
Photo No. ME 4

Location: Equipment Enclosure #2 Near Basketball Court: Outside Air Handling Unit 1 (OAU-1), Screws and Support
Remarks: Signs of finish failure.

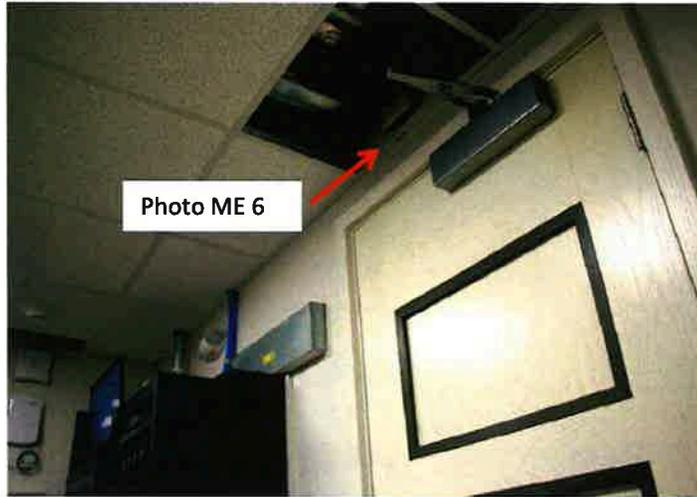
Photo No. ME 5

Location: Pro Shop: FACP Room
Remarks: AC unit above electrical equipment.

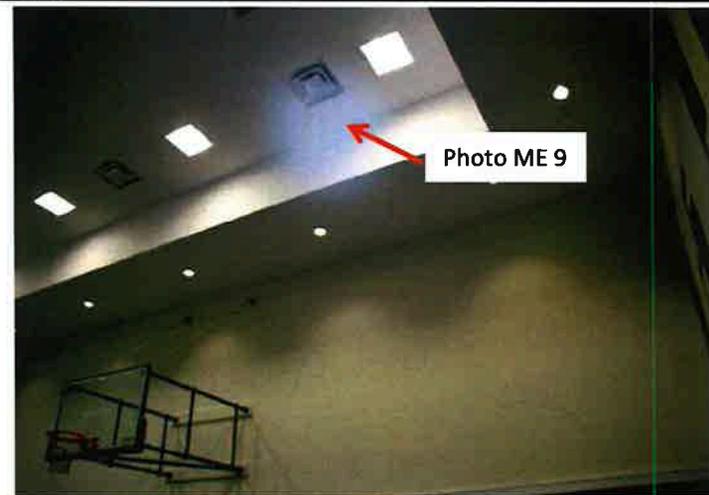
Photo No. ME 8

Location: Clubhouse: Sports Complex
Remarks: Condensation observed.

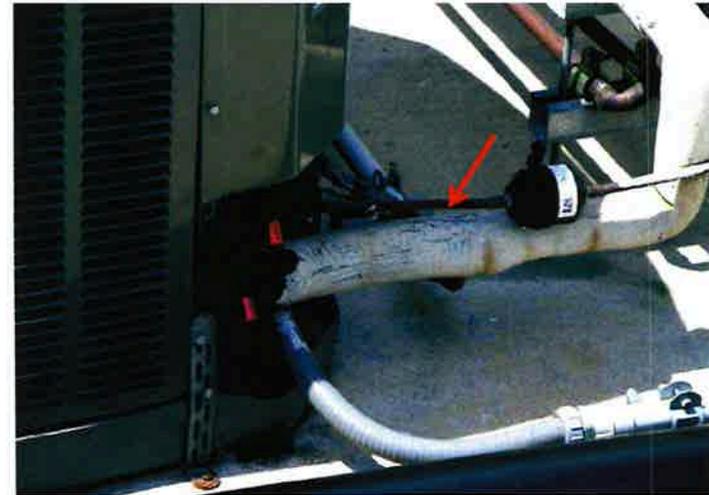
Photo No. ME 16

Location: Near Mechanical Room #1: Condensing Unit 3 (CU-3)

Remarks: Improper pipe insulation.

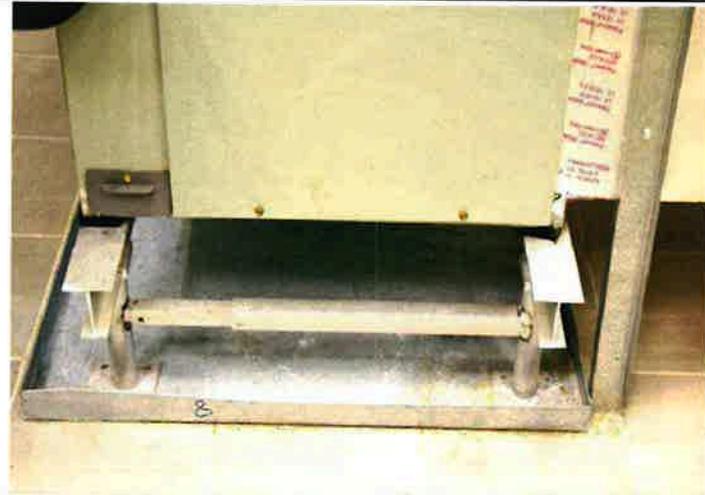
Photo No. ME 18

Location: Mechanical Room #3: Air Handling Unit 12 (AHU-12)

Remarks: Improper pipe support.

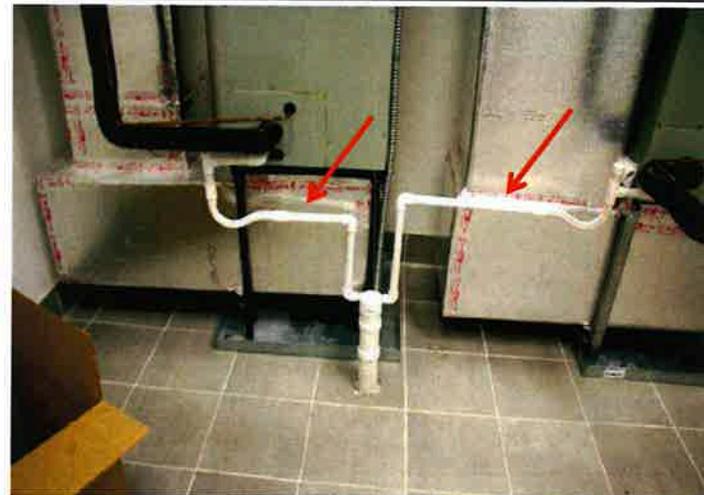
Photo No. ME 20

Location: Mechanical Room #3: Air Handling Unit 9 (AHU-9)

Remarks: Improper pipe support.

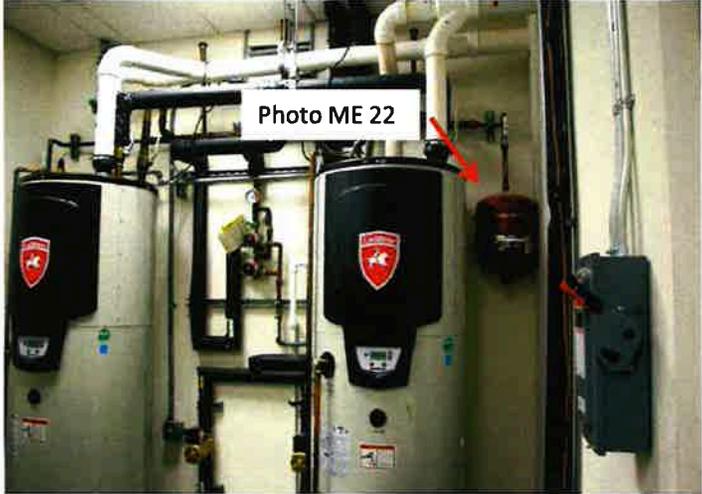
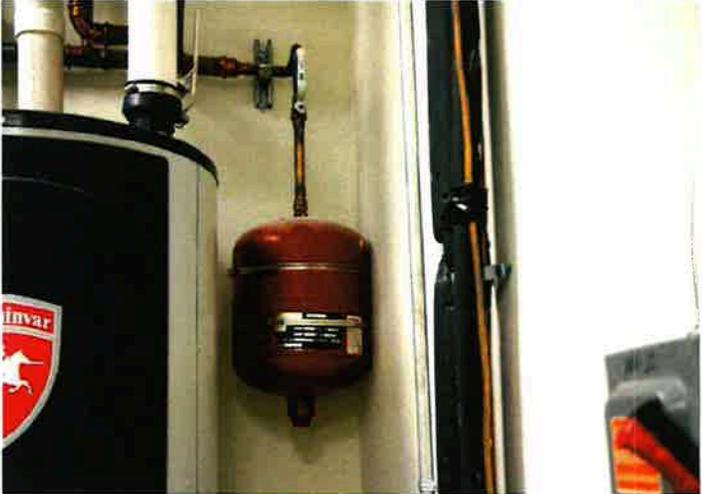
<p>Location: Mechanical Room #3: Expansion Tank</p> <p>Remarks: Improper support.</p>	<p>Location: Mechanical Room #3: Expansion Tank</p> <p>Remarks: Improper support.</p>
<p>Photo No. ME 23</p>

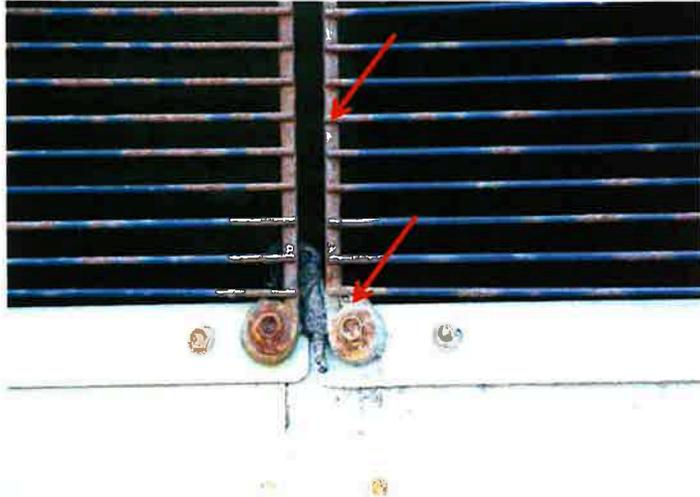
Photo No. ME 29

Location: Near Air Handling Unit 2 (OAU-2), Enclosure

Remarks: Signs of finish failure.

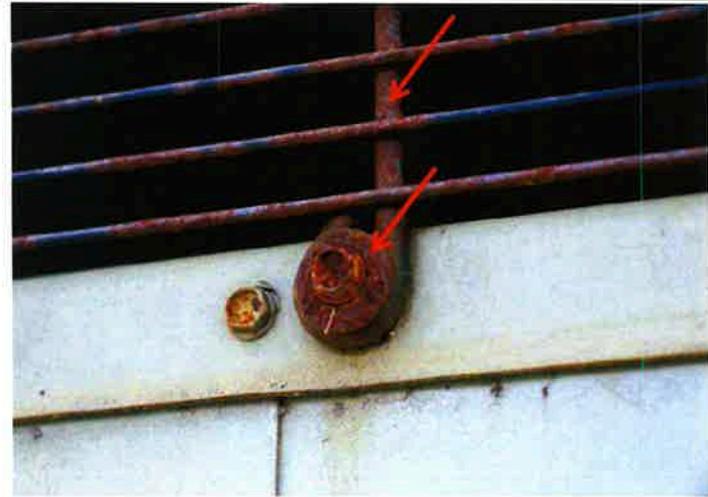
Photo No. ME 30

Location: Near Air Handling Unit 2 (OAU-2), Enclosure

Remarks: Signs of finish failure.

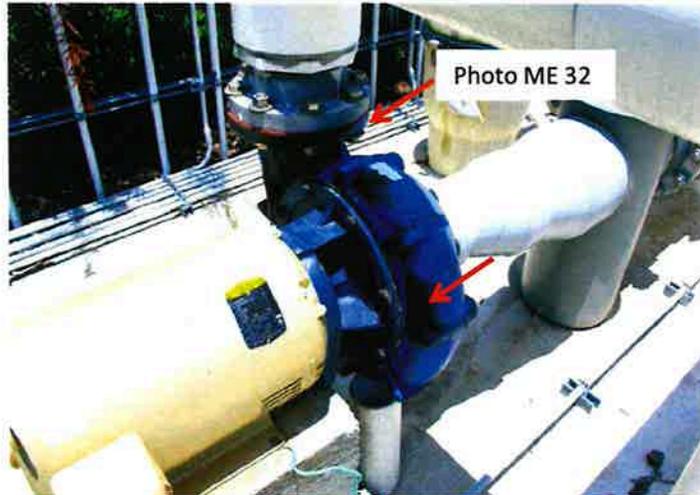
Photo No. ME 31

Location: East Gate Entrance: Fountain Equipment and Pump Area, All Pumps

Remarks: Signs of finish failure.

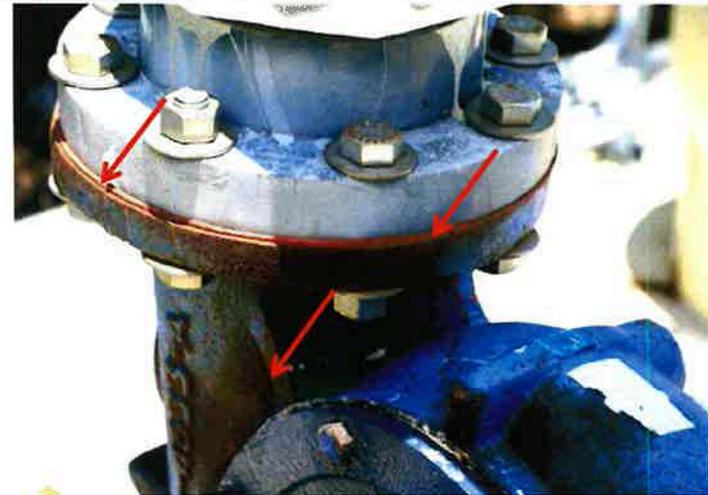
Photo No. ME 32

Location: East Gate Entrance: Fountain Equipment and Pump Area, All Pumps

Remarks: Signs of finish failure.

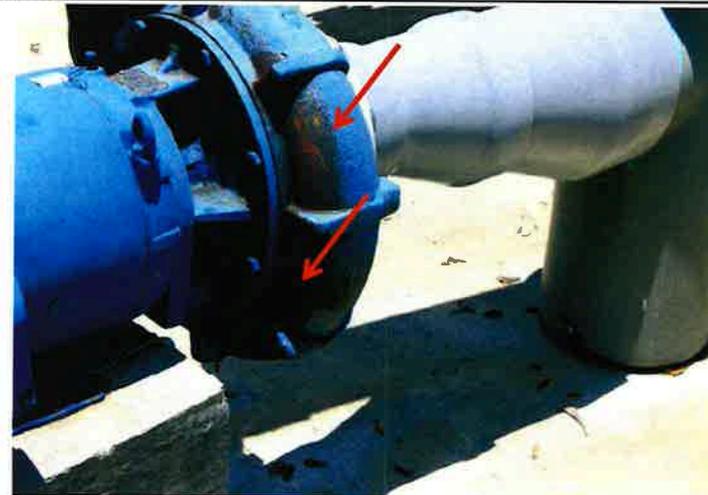
Photo No. ME 34

Location: East Gate Entrance: Fountain Equipment and Pump Area, All Pumps

Remarks: Signs of finish failure.

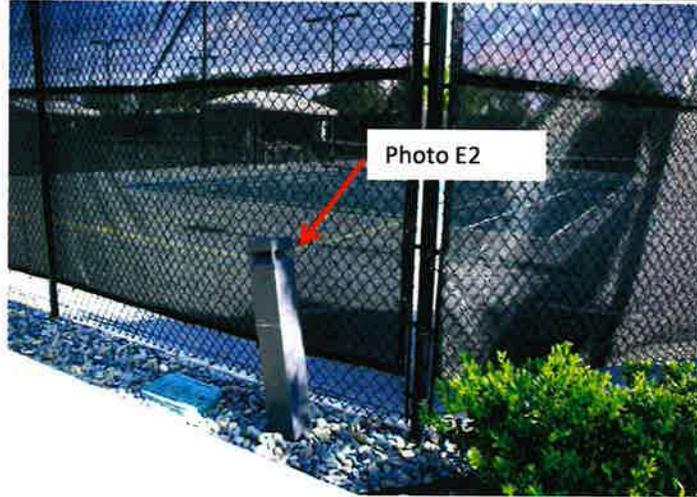
Photo No. E 1

Location: Tennis Court
Remarks: Bollard is not stable or secured.

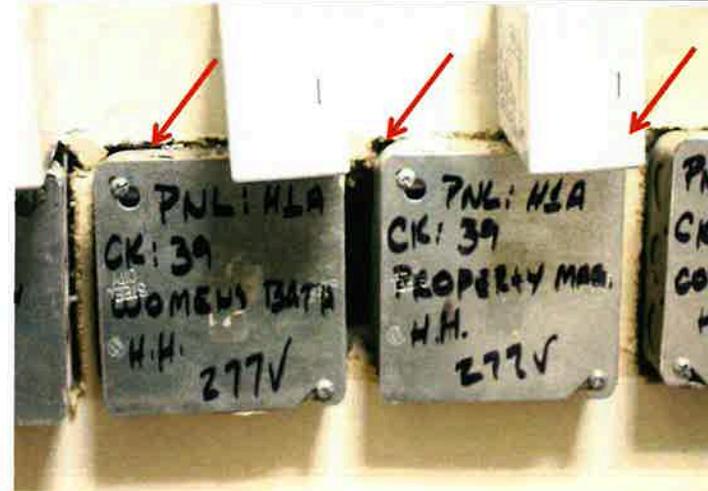
Photo No. E 12

Location: Clubhouse: Electrical Room

Remarks: Improper installation of electrical boxes.

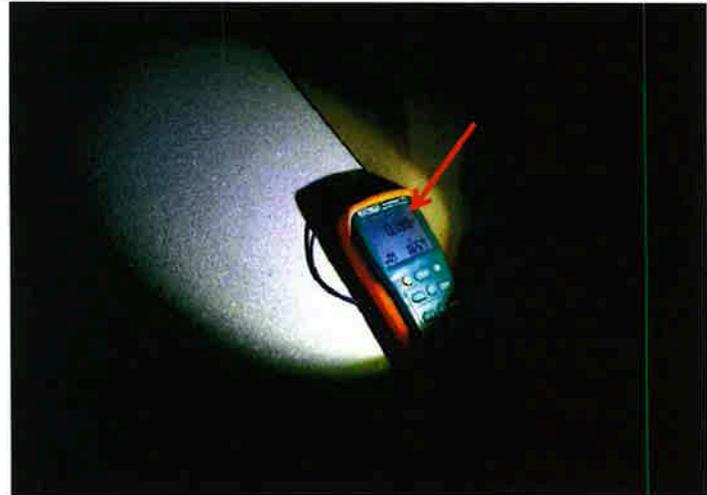
Photo No. E 14

Location: Pro Shop: Between North and Central Courts
Remarks: Inadequate illumination along means of egress.

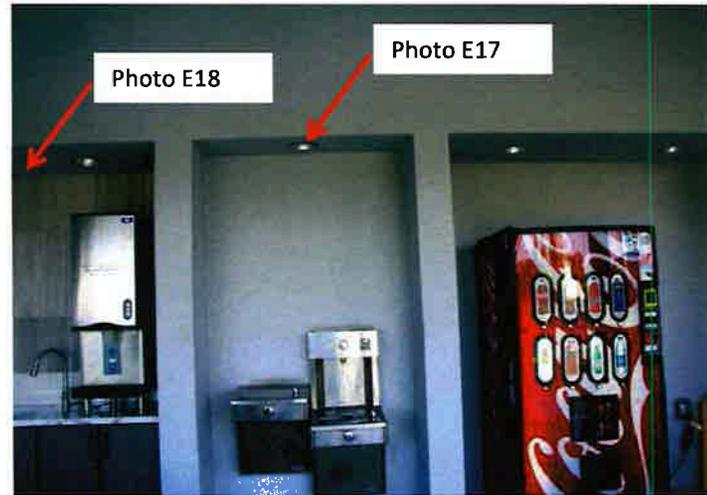
Photo No. E 16

Location: Near Pro Shop: Ceiling Light Fixtures
Remarks: Light fixtures are improperly installed.

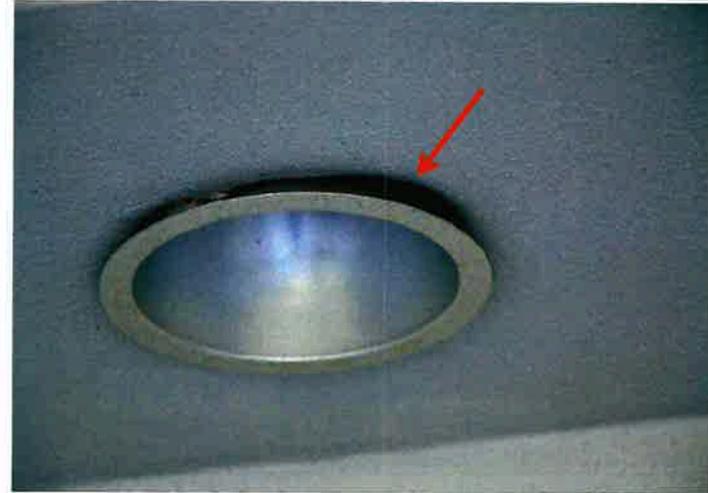
Photo No. E 18

Location: Near Pro Shop: Ceiling Light Fixtures

Remarks: Light fixtures are improperly installed.

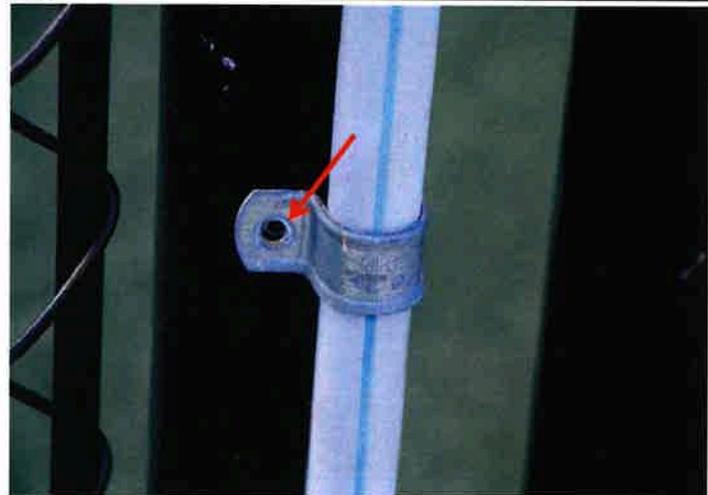
Photo No. E 20

Location: Tennis Court: Multiple Entrances

Remarks: Missing screws on conduit.

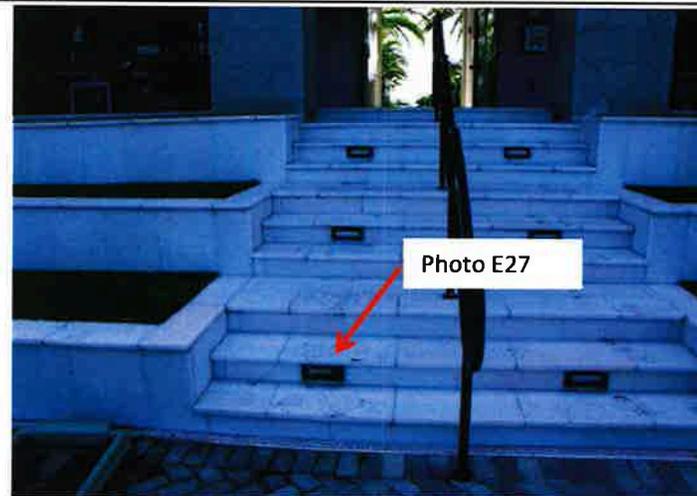
Photo No. E 26

Location: Pro Shop: West Stairs, Light Fixtures

Remarks: Signs of finish failure and water intrusion observed.

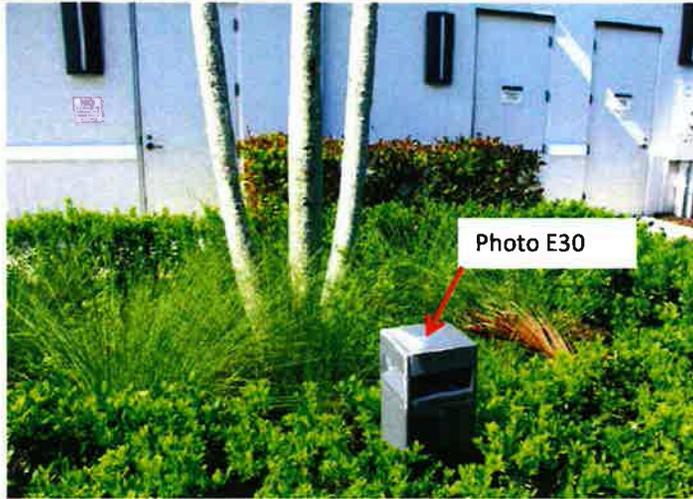
Photo No. E 29

Location: Pro Shop: Near Mechanical Room, Bollard

Remarks: Signs of finish failure.

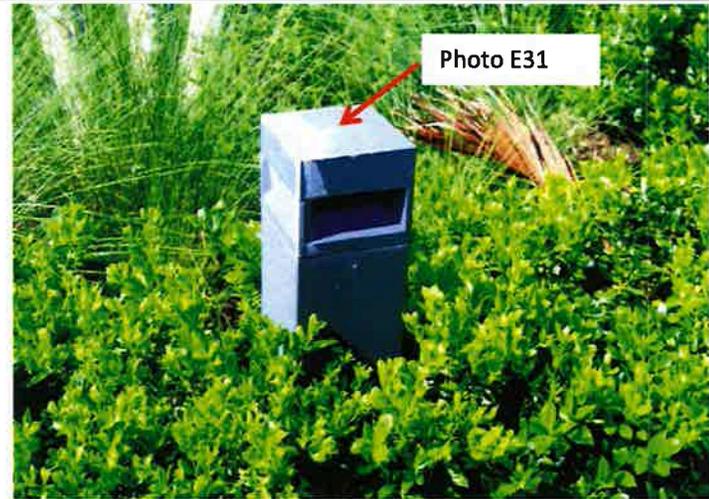
Photo No. E 30

Location: Pro Shop: Near Mechanical Room, Bollard

Remarks: Signs of finish failure.

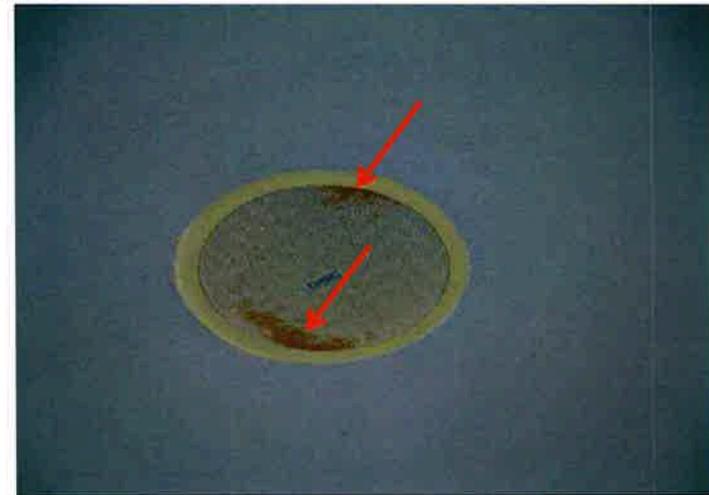
Photo No. E 32

Location: Near Pro Shop: Ceiling Speakers

Remarks: Signs of finish failure.

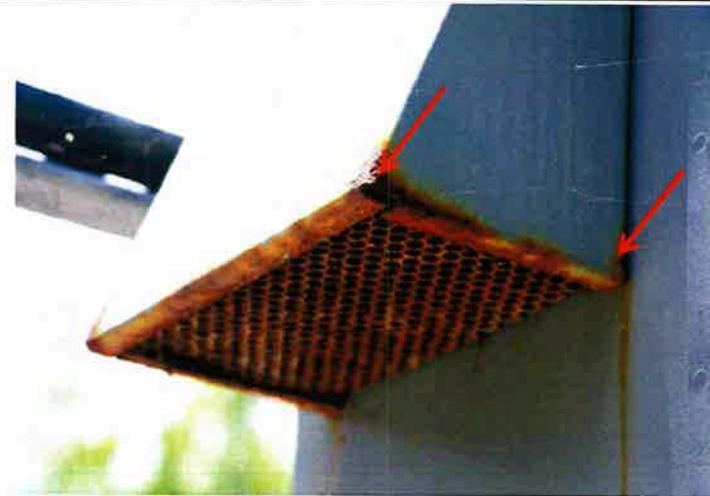
Photo No. E 34

Location: East Gate Entrance: Fountain Equipment and Pump Area, Electrical Panel

Remarks: Signs of finish failure.

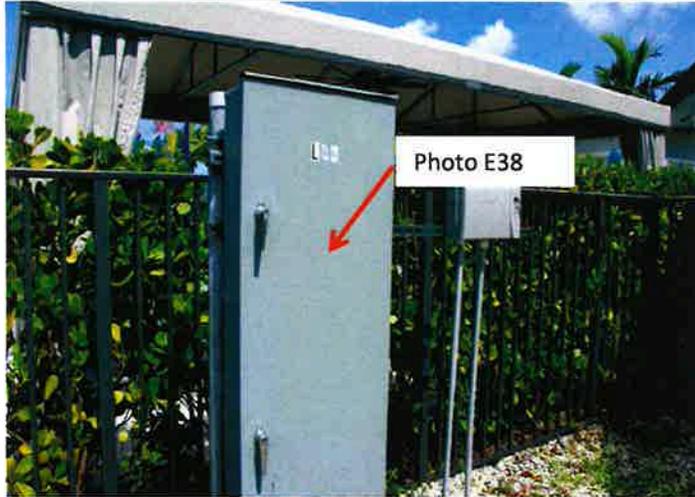
Photo No. E 37

Location: Pool Equipment Area: Electrical Panel
Remarks: Unidentified or improperly identified circuit breaker and panels.

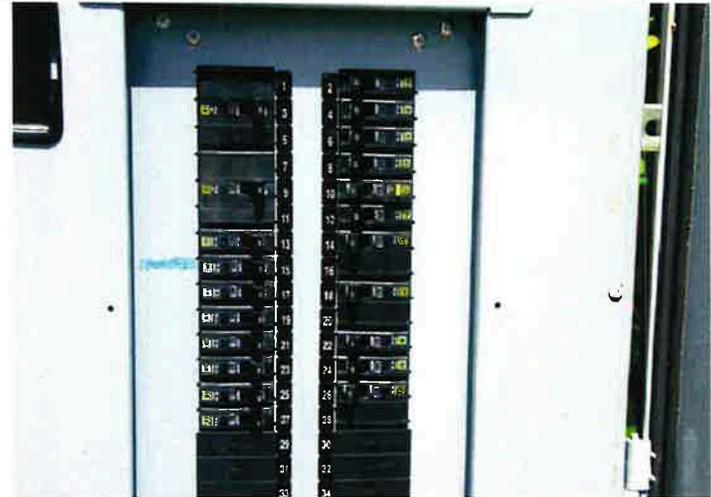
Photo No. E 38

Location: Pool Equipment Area: Electrical Panel
Remarks: Unidentified or improperly identified circuit breaker and panels.

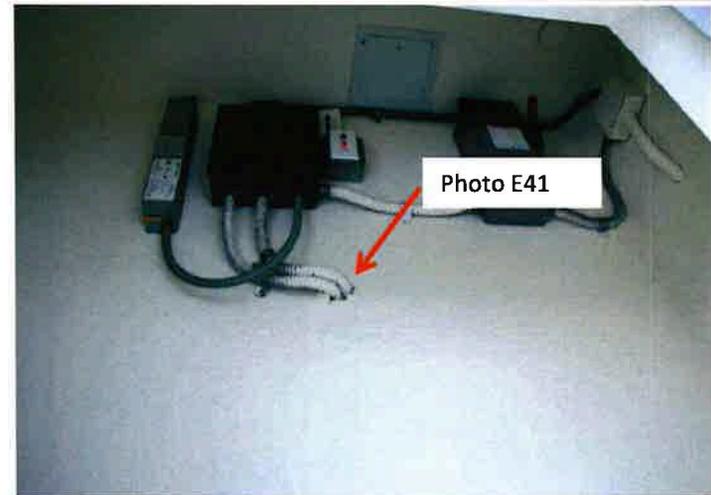
Photo No. E 40

Location: Pool Area: Janitorial Closet
Remarks: Unsealed penetration of electrical conduit.

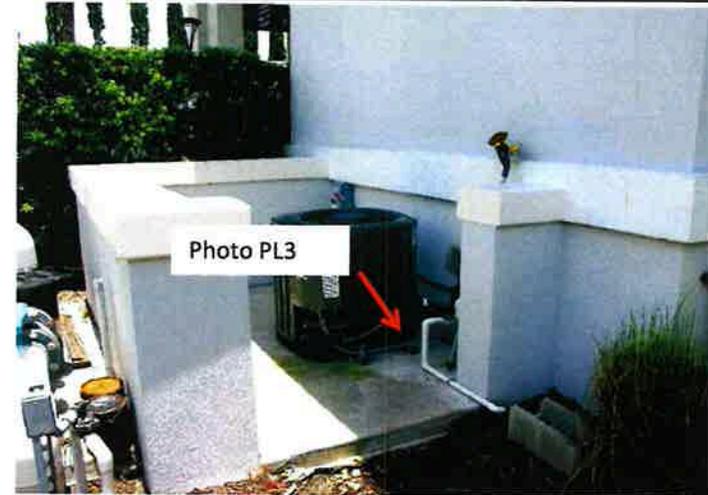
Photo No. PL 2

Location: East Gate Entrance: Guardhouse, Behind

Remarks: Improper drainage.

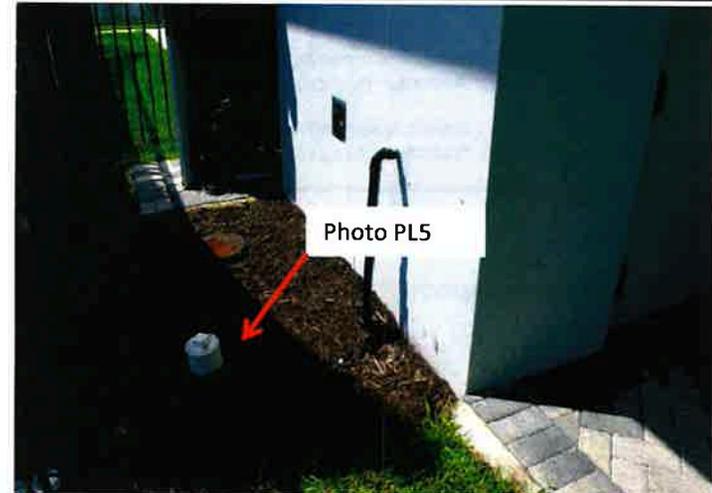
Photo No. PL 4

Location: Water Play Area: Near Unisex Bathroom, Pipe

Remarks: Pipe stub out in the service path of the mechanical room.

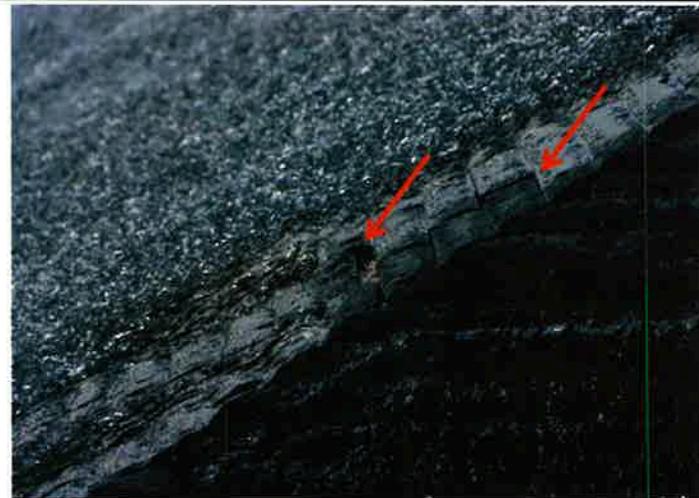
Photo No. PS 2

Location: East Entrance: South Pyramid Water Feature, Stone Tile

Remarks: Debonded tiles in select locations. Previous repairs evident.

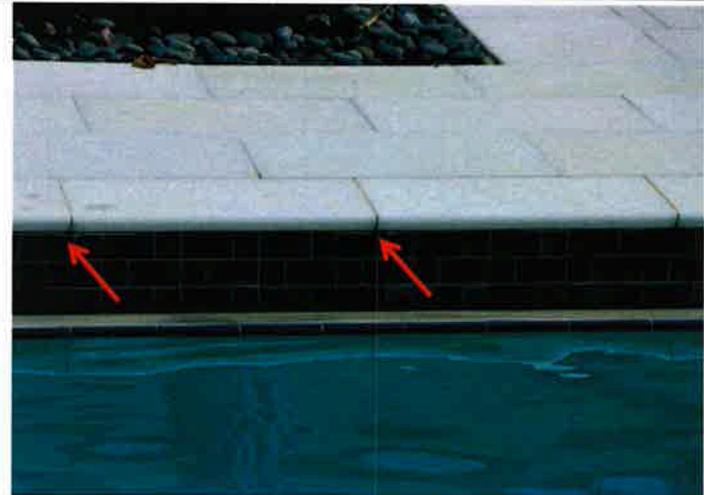
Photo No. PS 8

Location: Clubhouse: Main Pool, Coping

Remarks: Sealant not observed between coping and waterline tile.

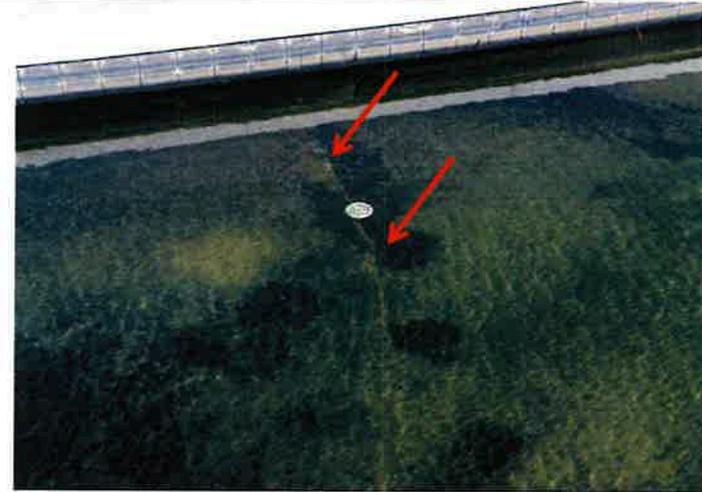
Photo No. PS 14

Location: East Entrance: South Pyramid Water Feature, Basin, Surface

Remarks: Crack(s).

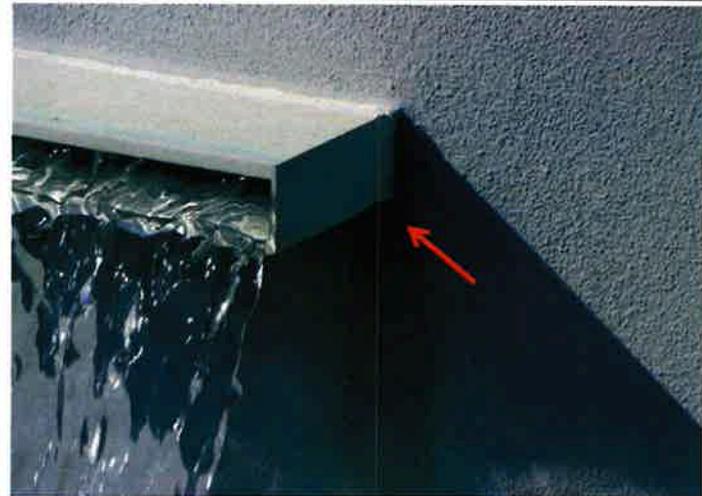
Photo No. PS 16

Location: Biltmore: Water Feature, Spout

Remarks: Spout not properly sealed. Leak(s) evident.

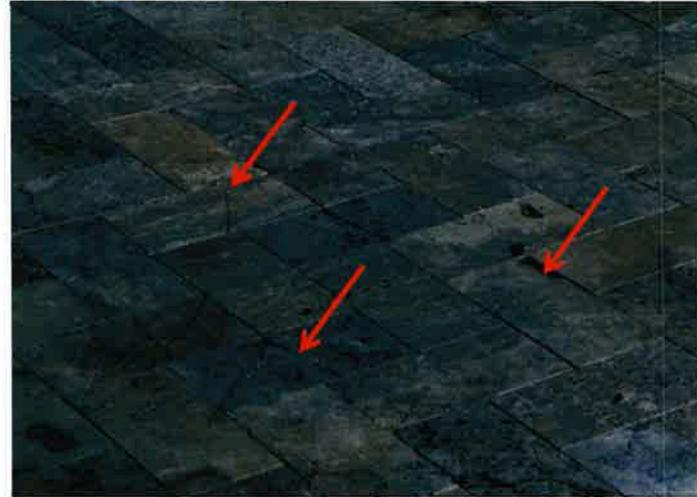
Photo No. PV 2

Location: The Enclave: 17217 Carretto Court

Remarks: Crack(s).

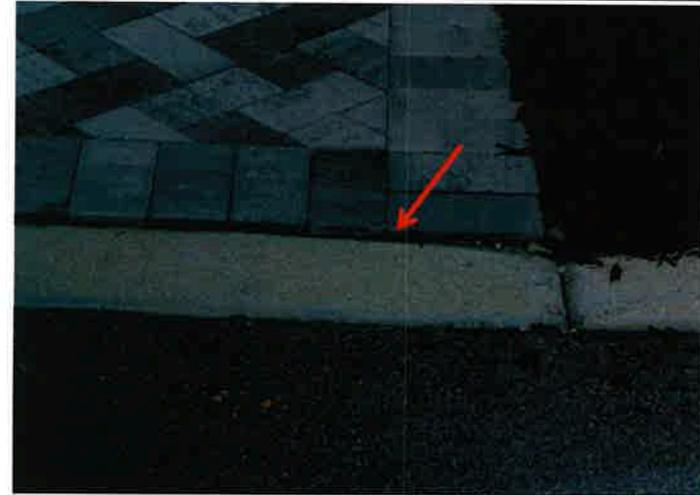
Photo No. PV 6

Location: Pro Shop: East Elevation, Paver Entrance from Parking Lot
Remarks: Change in elevation between edge restraint and pavers. Tripping hazard evident.

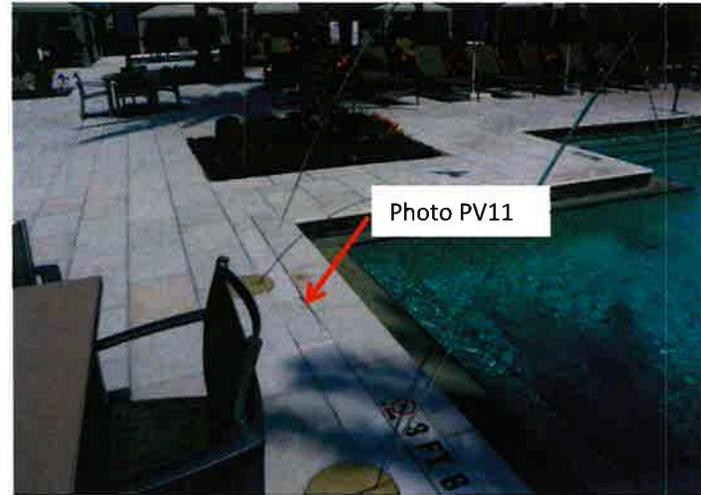
Photo No. PV 10

Location: Clubhouse: Main Pool, South Side, Deck, Pavers
Remarks: Pavers are settling unevenly. Tripping hazard evident.

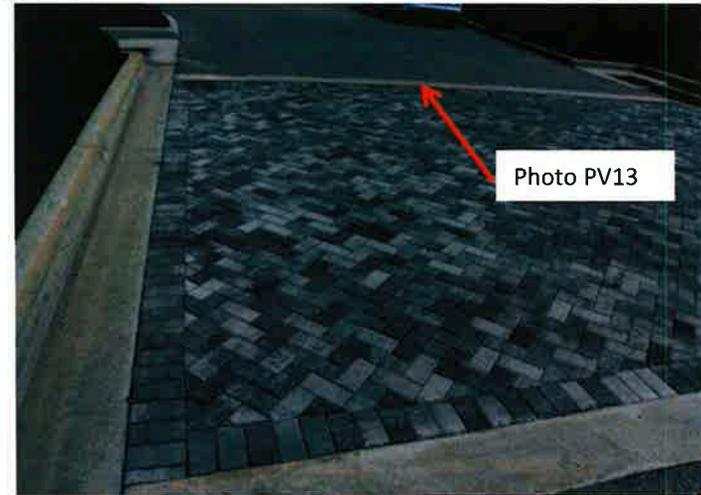
Photo No. PV 12

Location: Clubhouse: Entrance Near Sauvignon Parkway, Pavers
Remarks: Pavers are settling unevenly.

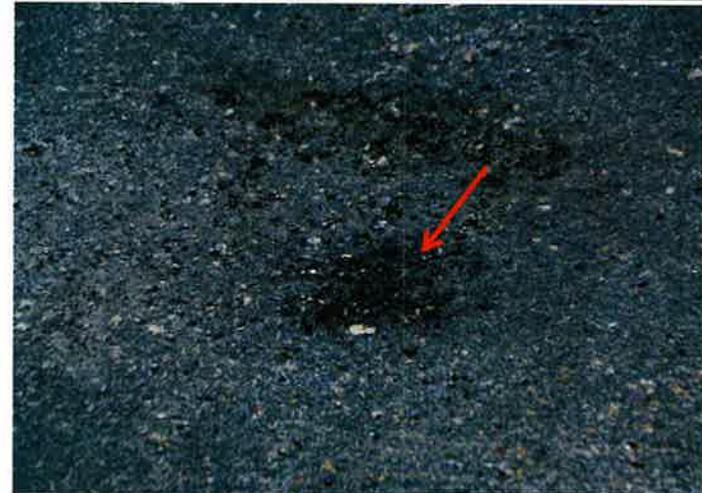
Photo No. PA 4

Location: Briarwood: Roundabout at the end of Ludovica Lane, Pavement

Remarks: Deterioration of asphalt.

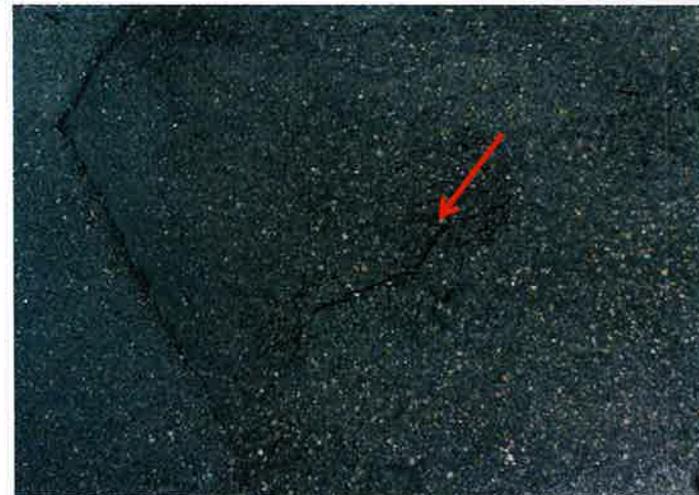
Photo No. PA 8

Location: Clubhouse: Parking Lot, East Side, Near Curb

Remarks: Crack(s).

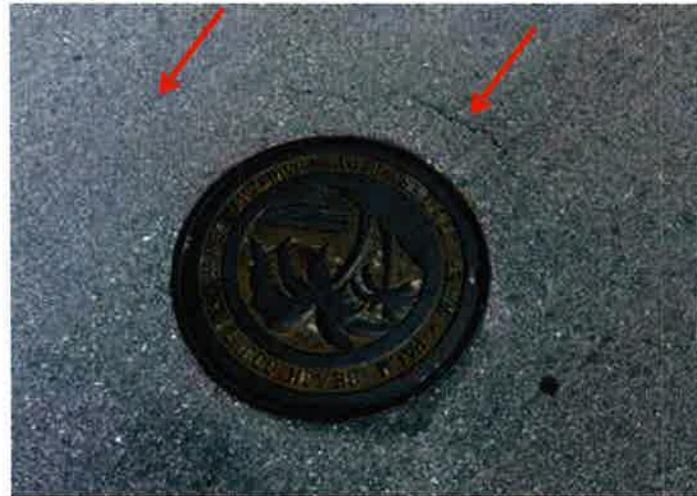
Photo No. PA 22

Location: Biltmore: 9763 Chianti Classico Terrace, Manhole Cover

Remarks: Reflection crack(s) in the road surface.

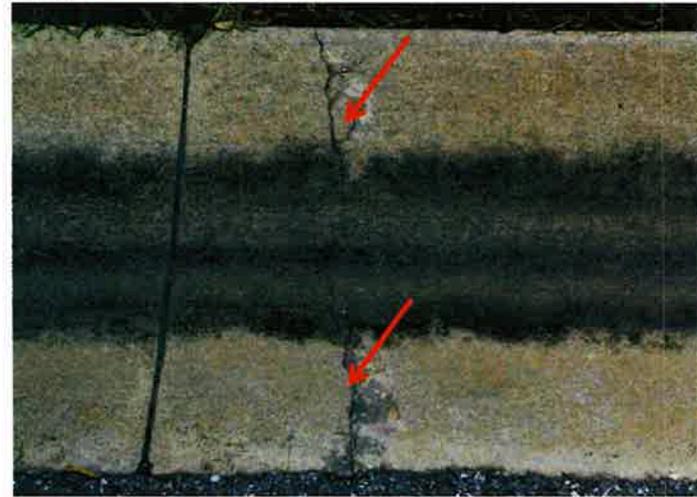
Photo No. CG 2

Location: Waldorf: 8987 Dulcetto Court, Gutter

Remarks: Crack(s). Spalls evident in select locations.

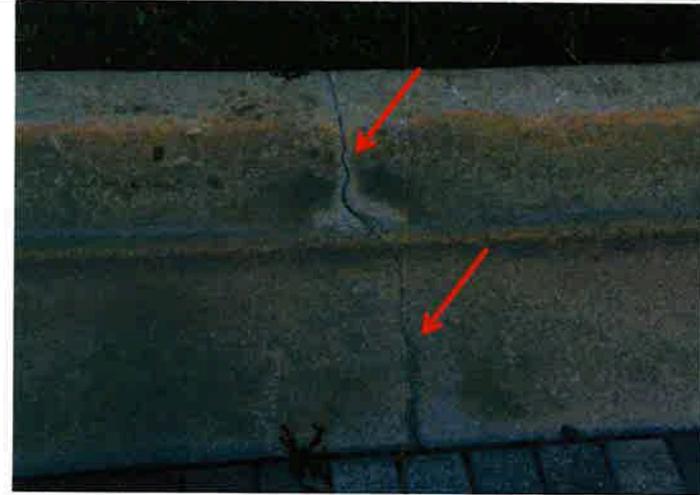
Photo No. CG 6

Location: Clubhouse: Entrance Near Sauvignon Parkway, Curb

Remarks: Crack(s).

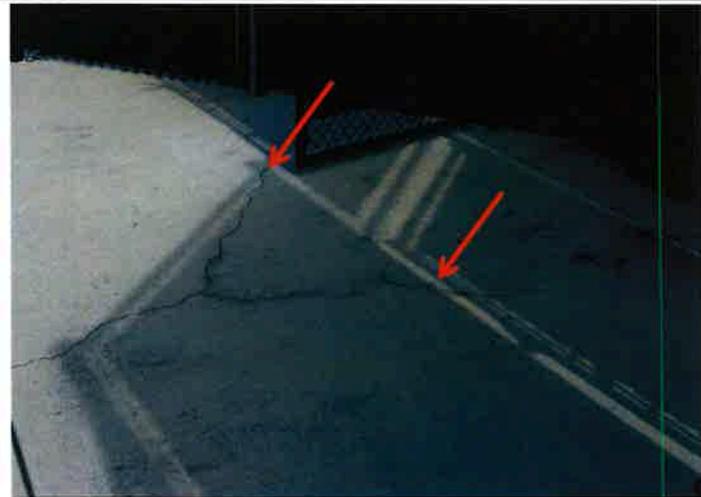
Photo No. S 2

Location: Pro Shop: Near the North Tennis Courts, Sidewalk

Remarks: Crack(s).

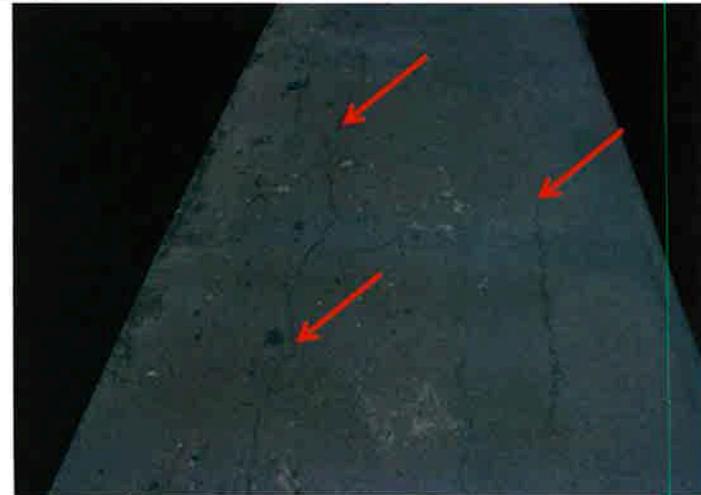
Photo No. S 4

Location: West Guardhouse: Bridge, Sidewalk

Remarks: Crack(s).

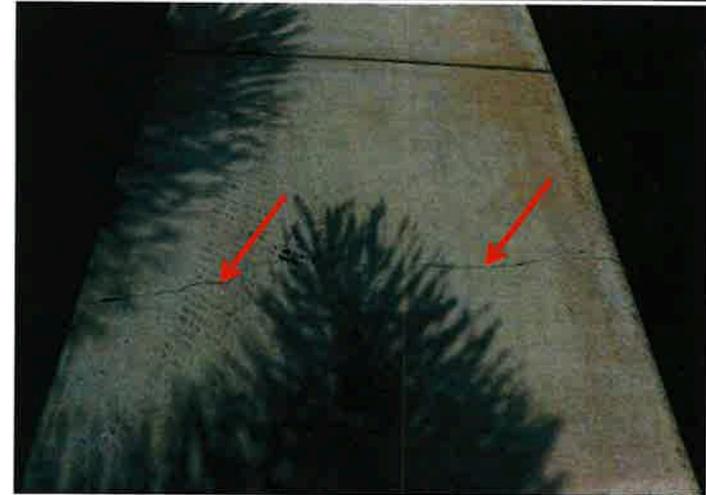
Photo No. S 6

Location: Cambridge: 17418 Rosella Road, Sidewalk

Remarks: Crack(s).

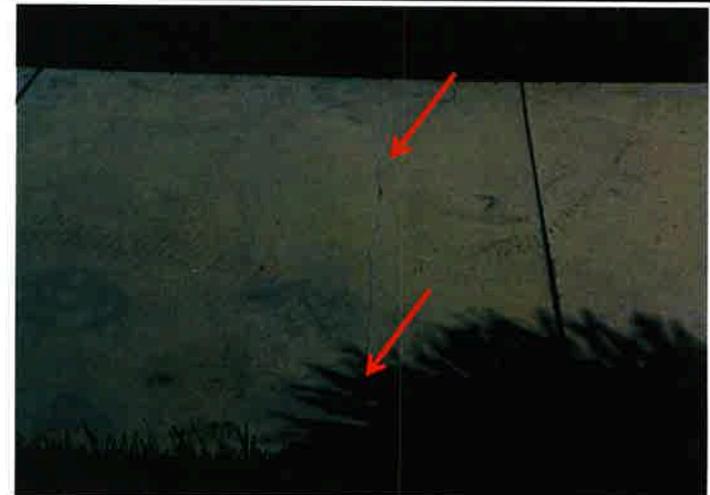
Photo No. S 8

Location: Biltmore: 9658 Chianti Classico Terrace, Sidewalk

Remarks: Crack(s).

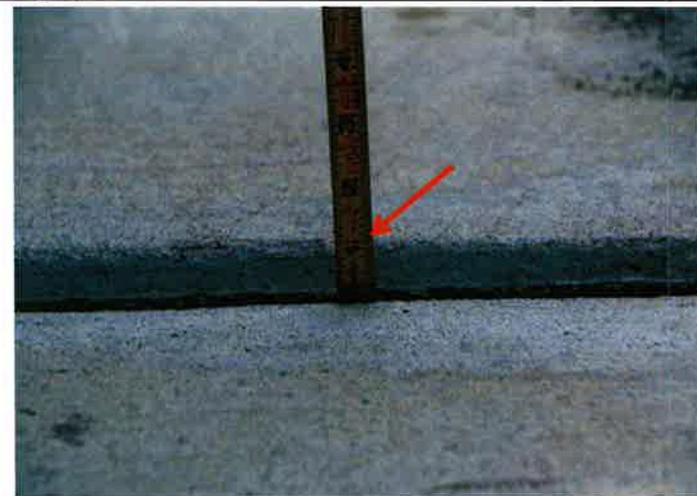
Photo No. S 12

Location: Brookside: 17378 Ristretto Trail, Sidewalk
Remarks: Elevation difference greater than 1/4 inch. Tripping hazard evident.

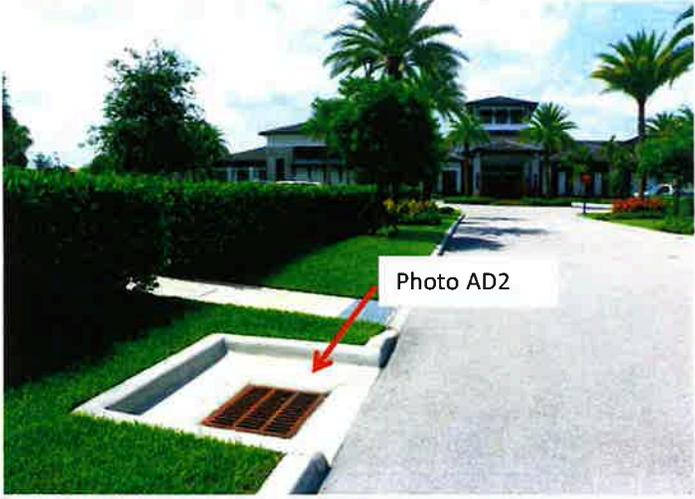
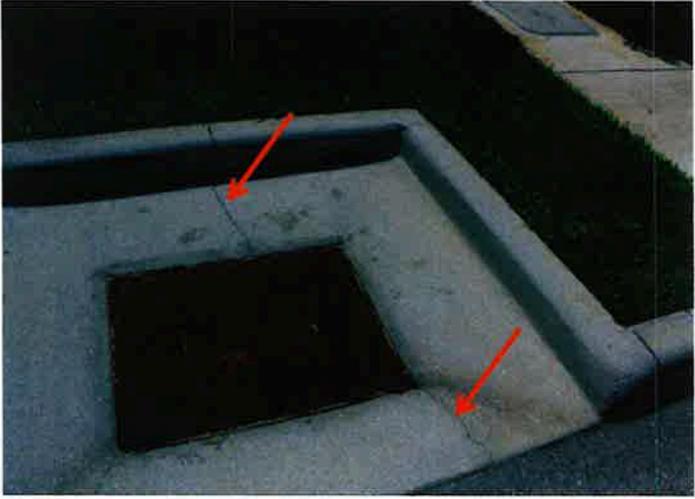
<p>Location: Clubhouse: Storm Drain Structure</p> <p>Remarks: Crack(s) in concrete.</p>	<p>Location: Clubhouse: Storm Drain Structure</p> <p>Remarks: Crack(s) in concrete.</p>
<p>Photo No. AD 3</p>

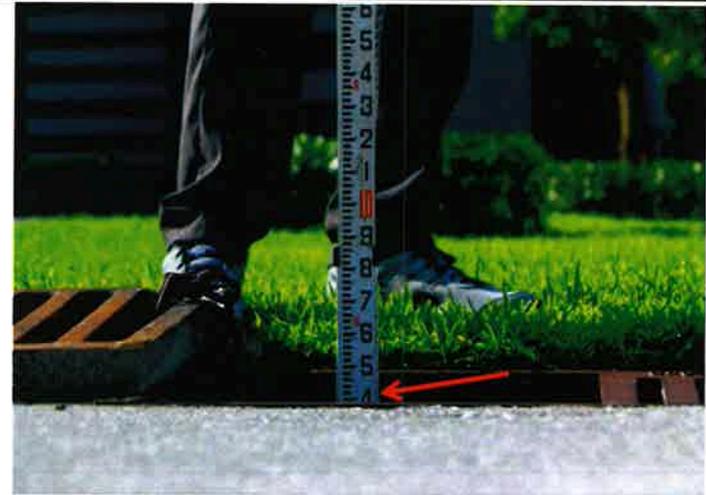
Photo No. AD 6

Location: Brookside: Near 9577 Vescovato Way, Drain

Remarks: Excessive sediment observed in catch basins.

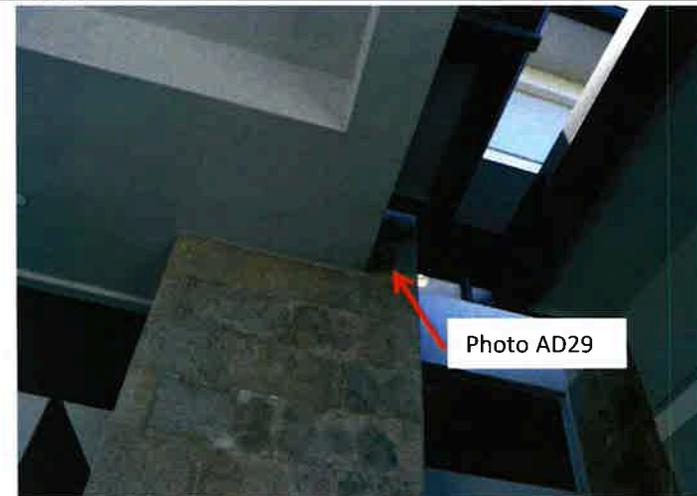
Photo No. AD 28

Location: Clubhouse: Near Entrance Doorway, Wall, Stone Cladding

Remarks: Discoloration of stone cladding.

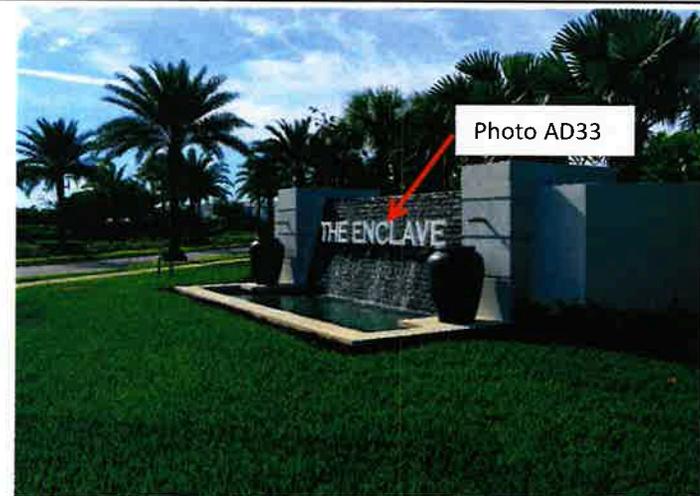
Photo No. AD 32

Location: The Enclave: Water Feature, Signage

Remarks: Finish is failing.

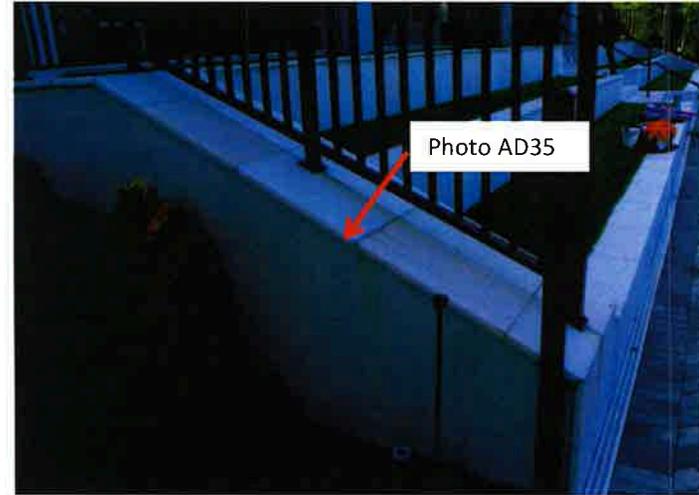
Photo No. AD 34

Location: Pro Shop: West Elevation, Tile Under Railing

Remarks: Efflorescence and moisture intrusion is evident.
