COMPLAINT

**Re: Boca Bridges Homeowners' Association, Inc.
Property Condition Assessment 558 Report**

Boca Bridges - Communities

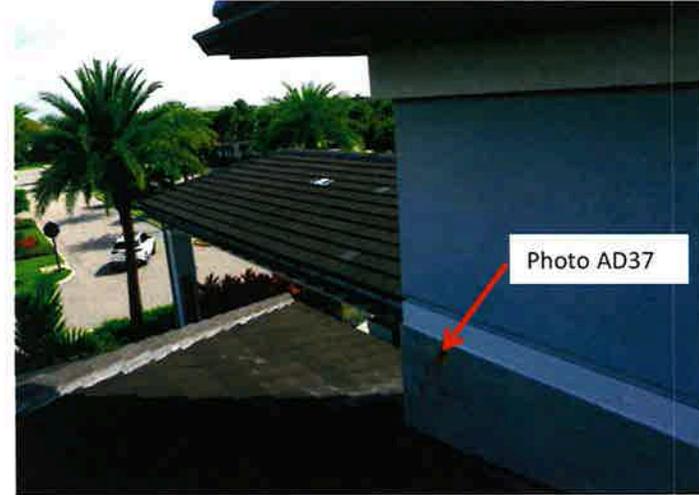
Photo No. AD 36

Location: Clubhouse: Tower above Lobby, Wall

Remarks: Rust stain.
