COMPLAINT

**Re: Boca Bridges Homeowners' Association, Inc.
Property Condition Assessment 558 Report**

Boca Bridges - Communities

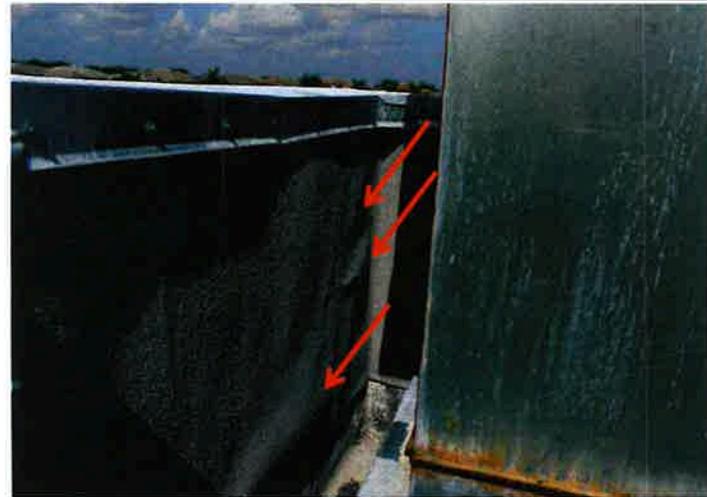
Photo No. R 2

Location: Clubhouse: Roof, Kitchen Vent Enclosure

Remarks: Blister(s).

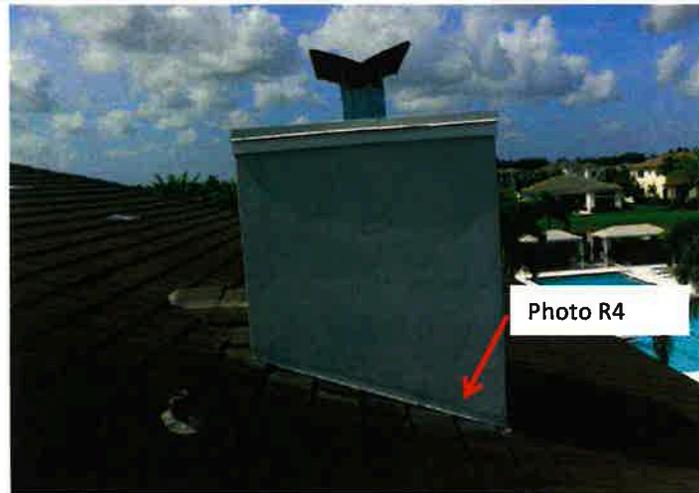
Photo No. R 3

Location: Clubhouse: Roof, Stucco-to-Counterflashing

Remarks: Cementitious material in contact with metal. Crack(s).

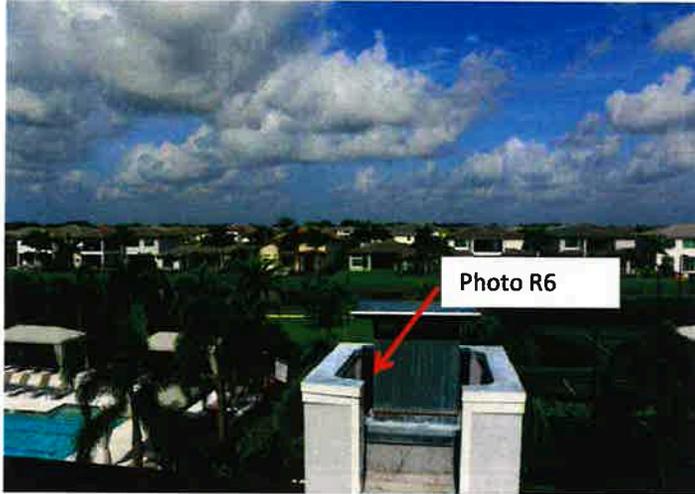
Photo No. R 5

Location: Clubhouse: Roof, Kitchen Vent Enclosure, Parapet Cap

Remarks: Finish is failing. Parapet cap not painted uniformly.

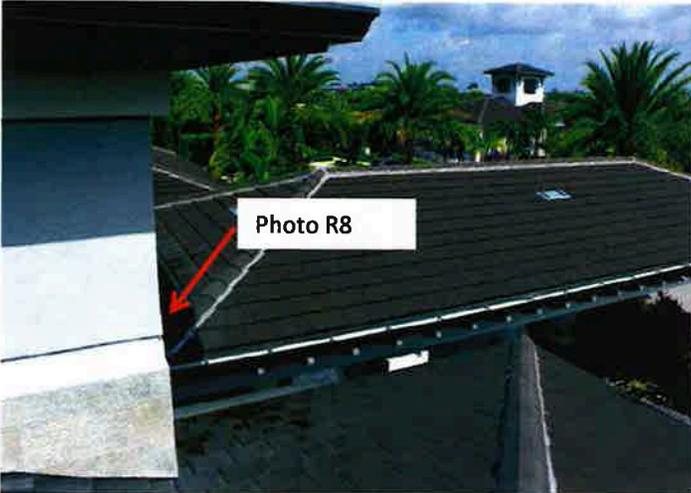
Photo No. R 7

4	Clubhouse: Roof, Above Covered Entrance	Signs of ponding water evident.	Code Violation	Roofing	2017 FBC - Building, Section 1502, definition for Positive Roof Drainage: "The drainage condition in which consideration has been made for all loading deflections of the roof deck, and additional slope has been provided to ensure drainage of the roof within 48 hours of precipitation."	R7, R8

Location: Clubhouse: Roof, Above Covered Entrance

Remarks: Signs of ponding water evident.

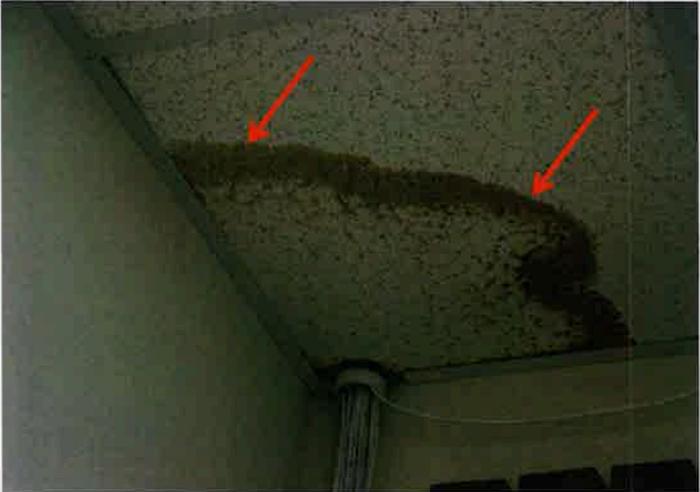
Line #	Location Description	Observation	Code Violation, Defect, Deviation, Improper Preturover Maintenance	Potential Attributable Scope of Work	Criterion and Notes	Typical Photo
5	Clubhouse: Electrical Room	Signs of water intrusion evident.	Code Violation / Deviation	Roofing	2017 FBC - Building, Section 1502, Definition of Roof Assembly: "A system designed to provide weather protection and resistance to design loads.." 2017 NRCA Roofing Manual: Steep-slope Roof Systems, Clay and Concrete Tile Roof Systems, Section 5.1, Definitions of Roof assembly and Roof System.	R9, R10

<p>Location: Clubhouse: Electrical Room</p> <p>Remarks: Signs of water intrusion evident.</p>	<p>Location: Clubhouse: Electrical Room</p> <p>Remarks: Signs of water intrusion evident.</p>

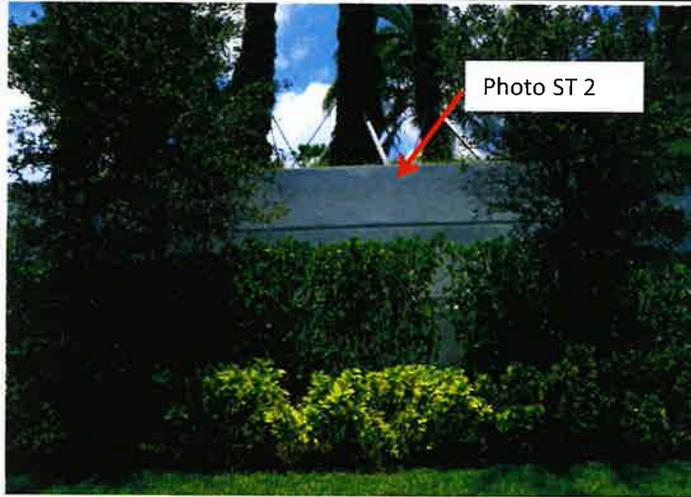
Photo No. ST 1

Location: East Entrance: Back of South Water Feature

Remarks: Crack(s).

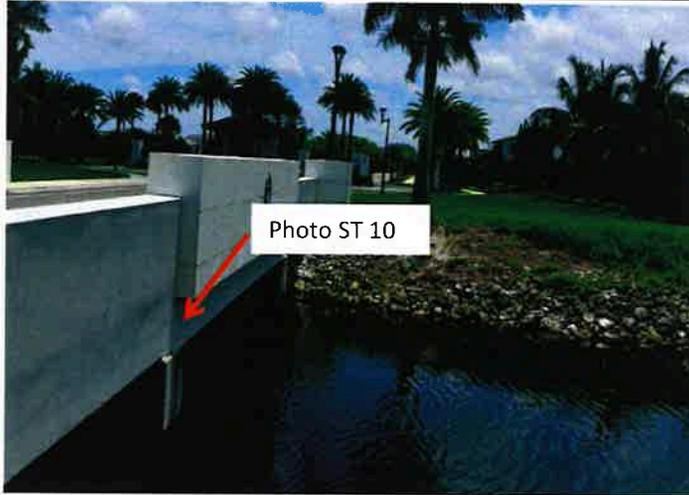
Photo No. ST 9

Location: North Entrance: Bridge

Remarks: Crack(s).

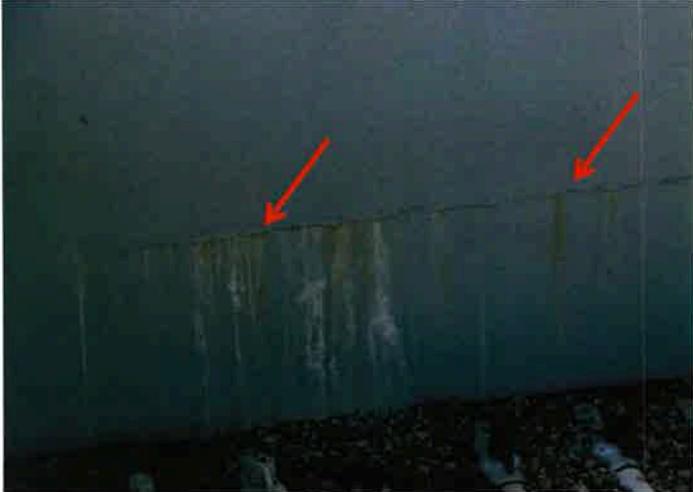
<p>Location: East Entrance: North Pyramid Water Feature, Planter, Wall</p> <p>Remarks: Crack(s). Efflorescence is evident.</p>	<p>Location: East Entrance: North Pyramid Water Feature, Planter, Wall</p> <p>Remarks: Crack(s). Efflorescence is evident.</p>

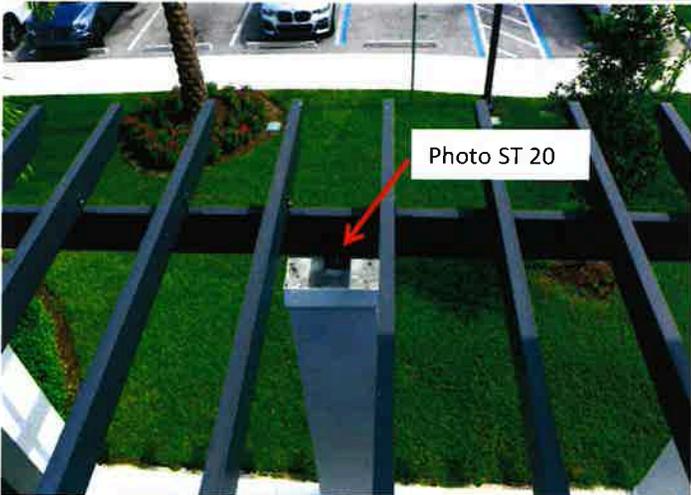
Photo No. ST 19

Location: Clubhouse: West Trellis, Top of Column

Remarks: Crack(s). Spalled, unpainted stucco.

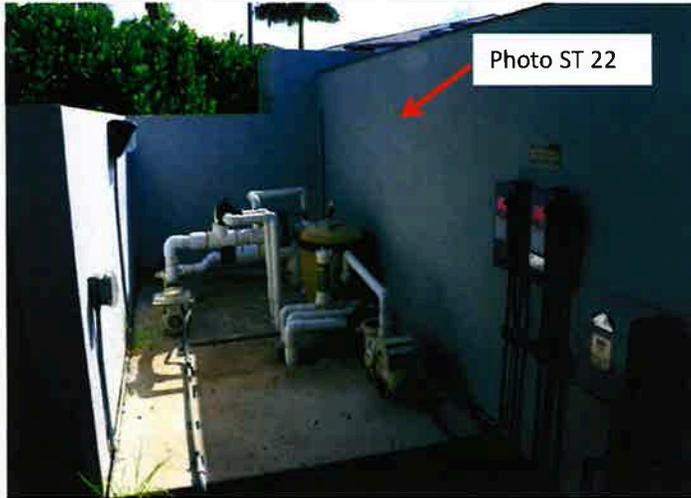
Photo No. ST 21

Location: The Enclave: Water Feature, Mechanical Enclosure, Wall

Remarks: Efflorescence is evident.

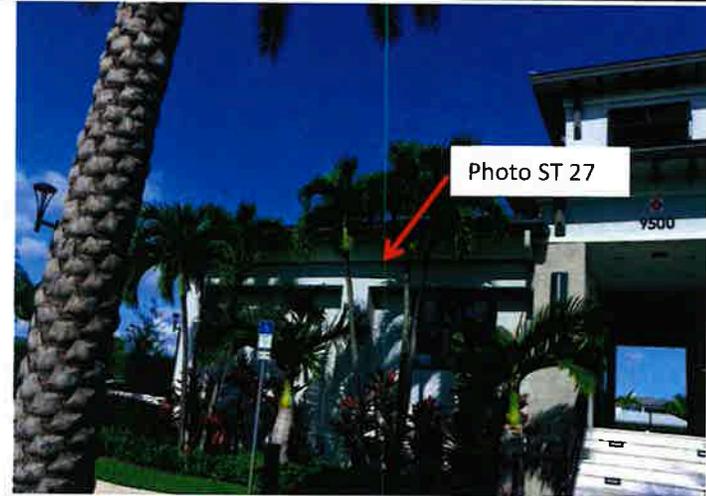
Photo No. ST 26

Location: Pro Shop: East Elevation, Wall

Remarks: Void(s) evident.

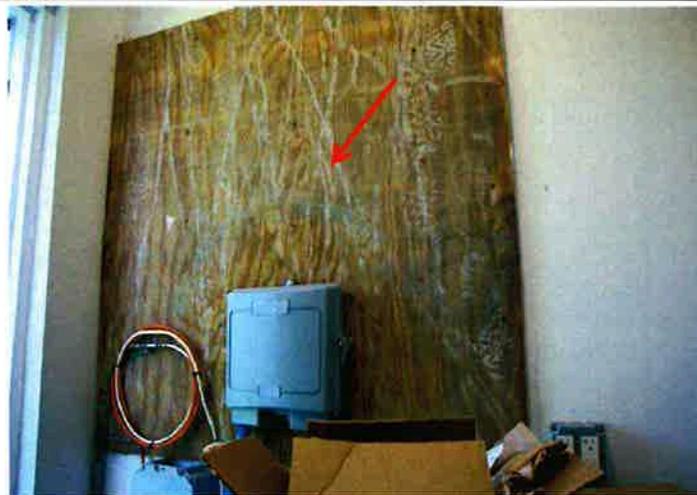
Photo No. ME 7

19	Pro Shop: FACP Room	AC unit above electrical equipment.	Code Violation	Mechanical	<p>2017 FBC - Mechanical - Chapter 3, Section 303.2 Hazardous locations.</p> <p>2014 Edition of NFPA 70 (NEC), Section 110.26(1)(a) Dedicated Electrical Space.</p>	ME5, ME6
20	Pro Shop: Electrical Room	Combustible material was observed within plenum.	Code Violation	Mechanical	2017 FBC - Mechanical - Chapter 6, Section 602.2.1 Materials within plenums.	ME7

Location: Pro Shop: Electrical Room
Remarks: Combustible material was observed within plenum.

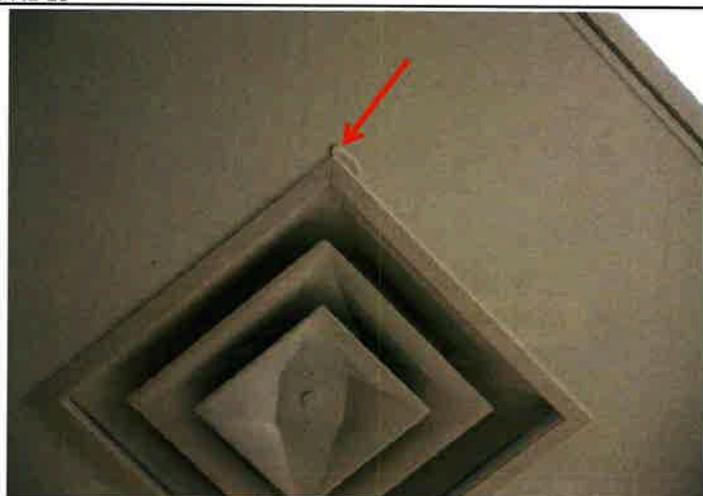
<p>Location: Clubhouse: Sports Complex</p> <p>Remarks: Condensation observed.</p>	<p>Location: Clubhouse: Sports Complex</p> <p>Remarks: Condensation observed.</p>
<p>Photo No. ME 11</p>

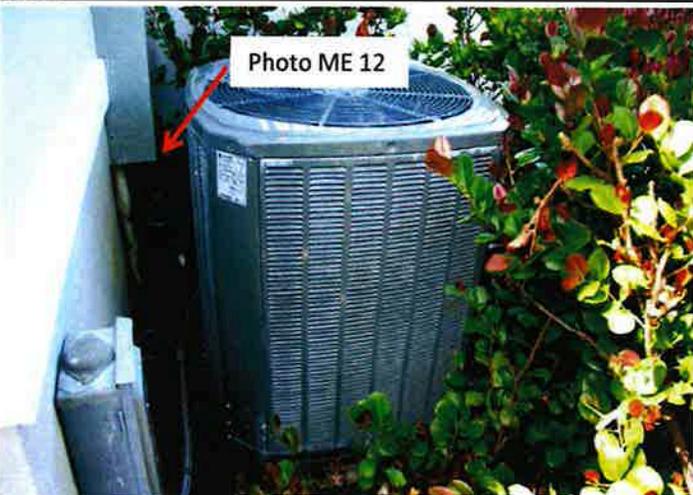
<p>Location: Pro Shop: Near Electrical Room, Outside Air Condensing Unit 1 (OACU-1)</p> <p>Remarks: Condensing unit does not have adequate service clearance.</p>	<p>Location: Pro Shop: Near Electrical Room, Outside Air Condensing Unit 1 (OACU-1)</p> <p>Remarks: Condensing unit does not have adequate service clearance.</p>

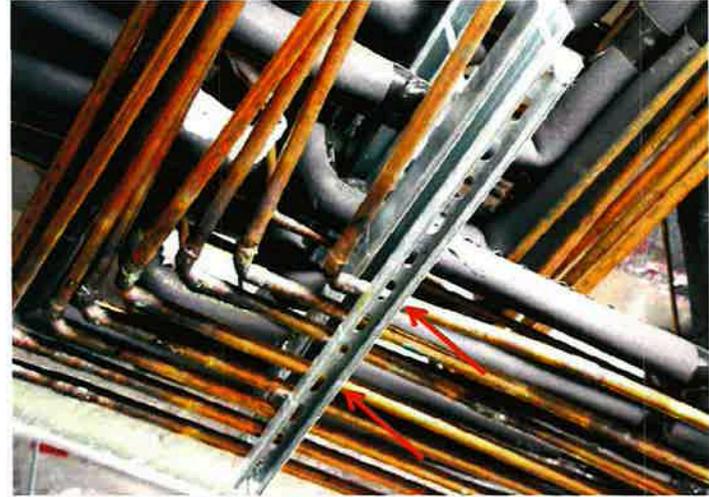
Photo No. ME 14

Line #	Location Description	Observation	Code Violation, Defect, Deviation, Improper Preturbover Maintenance	Potential Attributable Scope of Work	Criterion and Notes	Typical Photo
21	Clubhouse: Sports Complex	Condensation observed.	Code Violation	Mechanical	2017 FBC - Mechanical - Chapter 6, Section 603.12 Condensation.	ME8, ME9, ME10
22	Pro Shop: Near Electrical Room, Outside Air Condensing Unit 1 (OACU-1)	Condensing unit does not have adequate service clearance.	Code Violation / Deviation	Mechanical	Mechanical Plans - M7.1 - Condensing Unit Mounting Detail 2017 FBC - Mechanical, Chapter 3, Section 306.1 Access.	ME11, ME12
23	Near Mechanical Room #3: Condensing Unit 12 (CU-12) and Condensing Unit 10 (CU-10), Pipes Near Mechanical Room #1: Condensing Unit 3 (CU-3), Pipes Condensing Unit 1 (CU-1): Pipes Mechanical Room #1: Ceiling Pipes (Typical Photo)	Copper pipes are in direct contact with steel piping supports.	Code Violation / Deviation	Mechanical	2017 FBC - Mechanical - Chapter 12, Section 1206.4 Pipe penetrations. 2017 FBC - Mechanical - Chapter 12, Section 1206.6 Contact with building material. Plans: Pro Shop, Plumbing, Sheet P0.1, Note (18).	ME13, ME14

Location: Mechanical Room #1: Ceiling Pipes

Remarks: Copper pipes are in direct contact with steel piping supports.

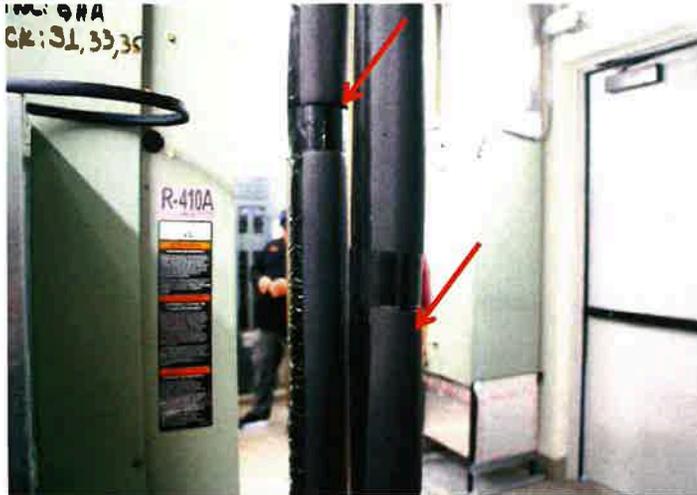
Photo No. ME 15

Location: Mechanical Room #1: Outside Air Handling Unit 1

Remarks: Improper pipe insulation .

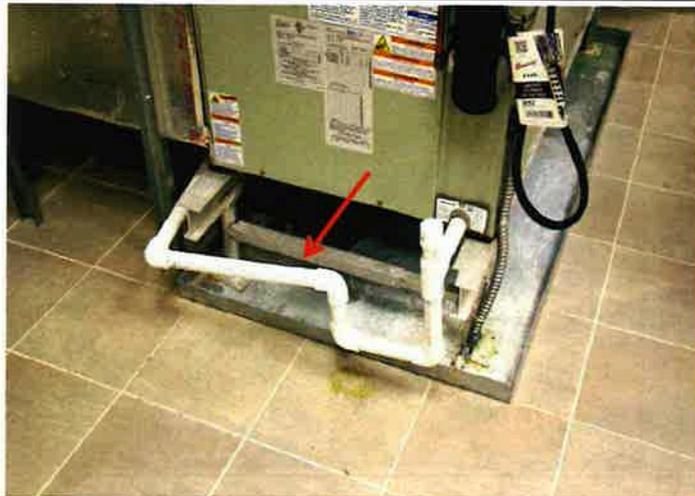
Photo No. ME 19

Location: Mechanical Room #3: Air Handling Unit 11 (AHU-11)

Remarks: Improper pipe support.

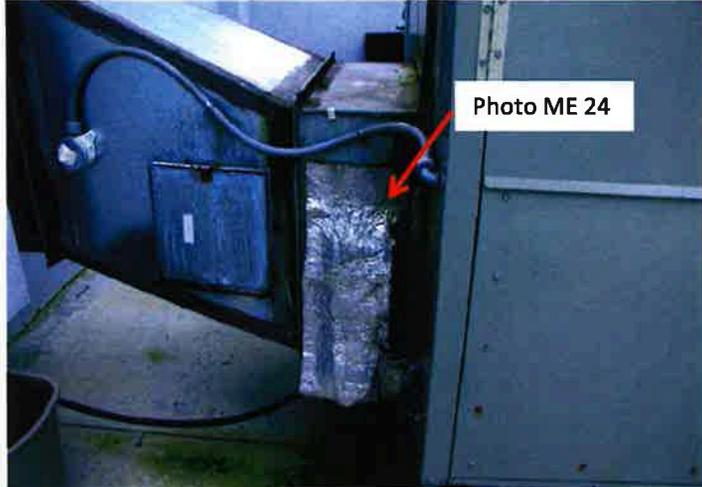
<p>Location: Mechanical Room #3: Expansion Tank</p> <p>Remarks: Improper support.</p>	<p>Location: Mechanical Room #3: Expansion Tank</p> <p>Remarks: Improper support.</p>
<p>Photo No. ME 23</p>

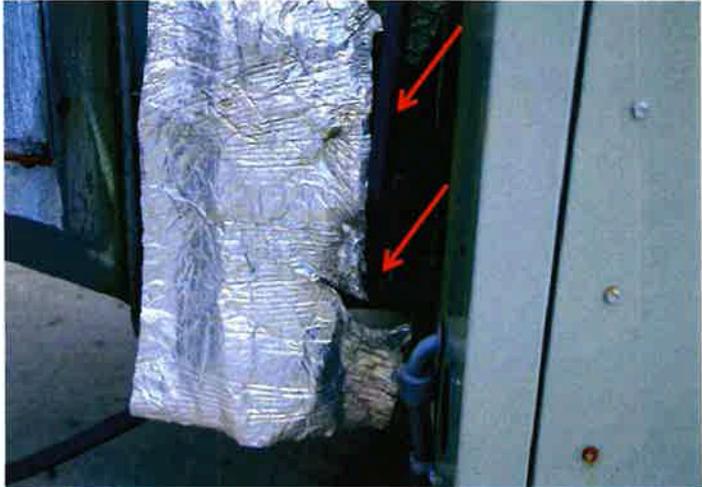
<p>Photo No. ME 24</p>

<p>Location: Near Air Handling Unit 3 (OAU-3)</p> <p>Remarks: Incomplete insulation.</p>	<p>Location: Near Air Handling Unit 3 (OAU-3)</p> <p>Remarks: Incomplete insulation.</p>

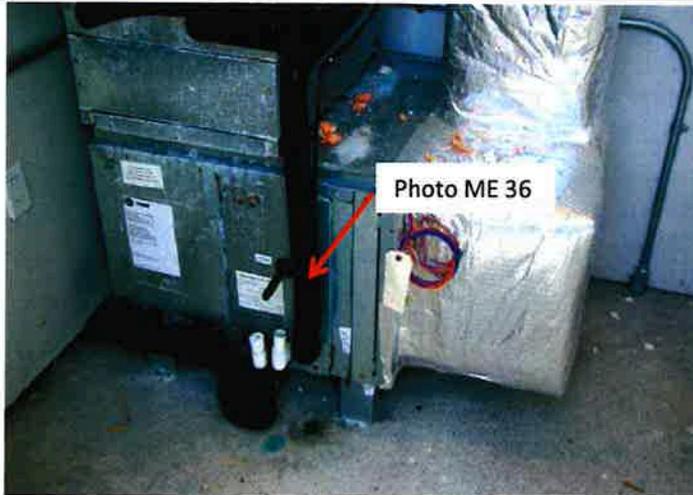
Photo No. ME 35

Location: Pro Shop: Mechanical Room

Remarks: Uncapped pipe.

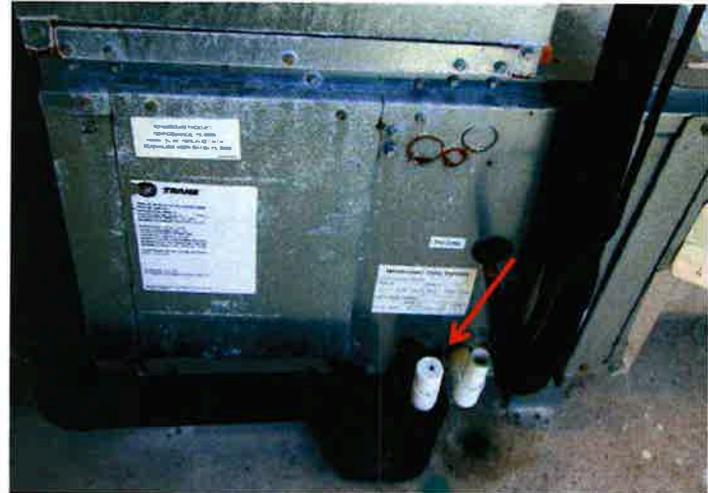
Photo No. ME 36

Location: Pro Shop: Mechanical Room

Remarks: Uncapped pipe.

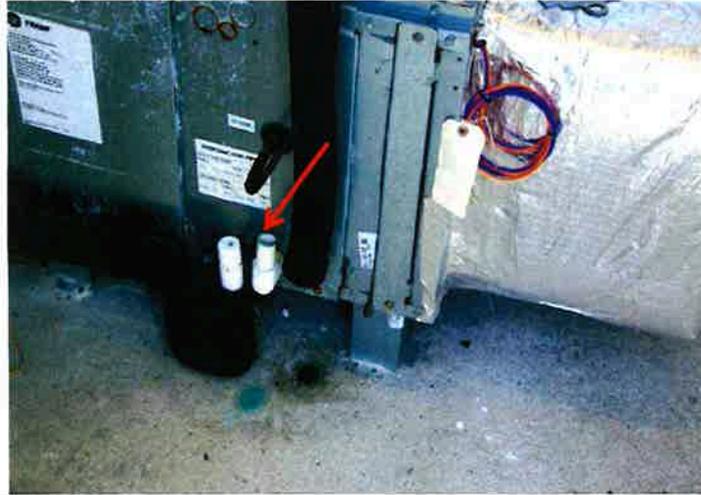
Photo No. ME 37

Location: Pro Shop: Mechanical Room

Remarks: Uncapped pipe.

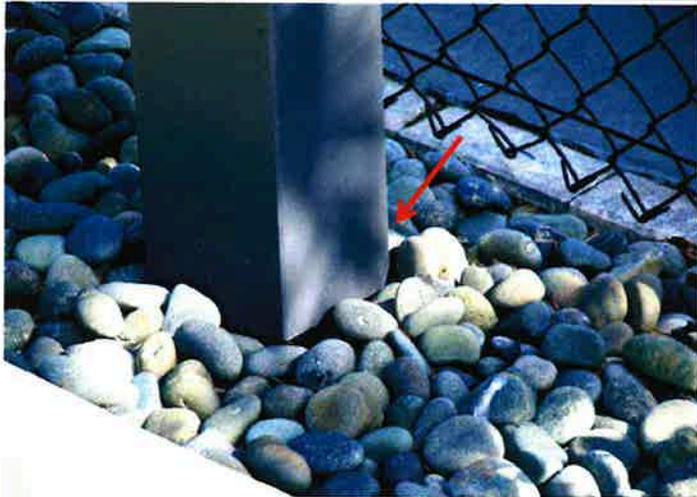
Photo No. E 3

Location: Tennis Court
Remarks: Bollard is not stable or secured.

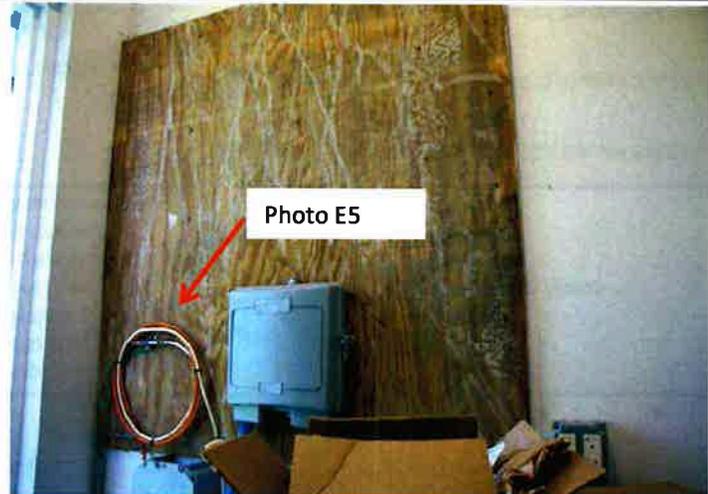
Photo No. E 4

Location: Pro Shop: Electrical Room
Remarks: Exposed wiring.

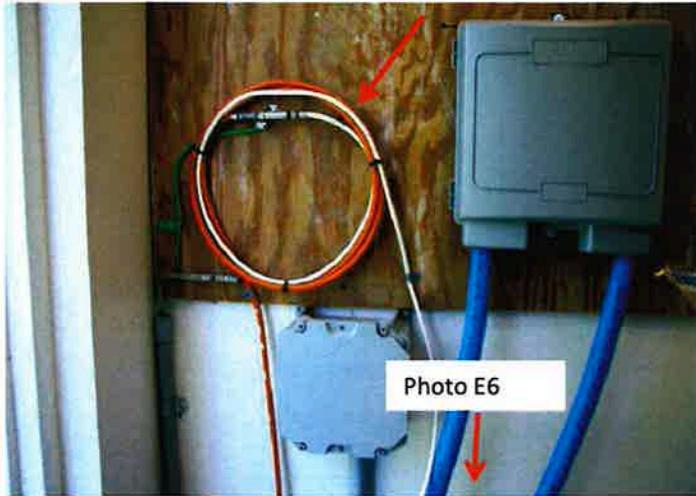
Photo No. E 5

Location: Pro Shop: Electrical Room

Remarks: Exposed wiring.

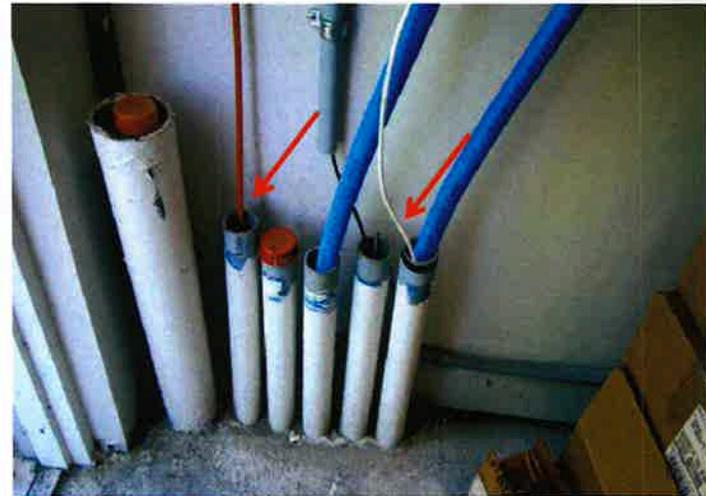
Photo No. E 6

Location: Pro Shop: Electrical Room

Remarks: Exposed wiring.

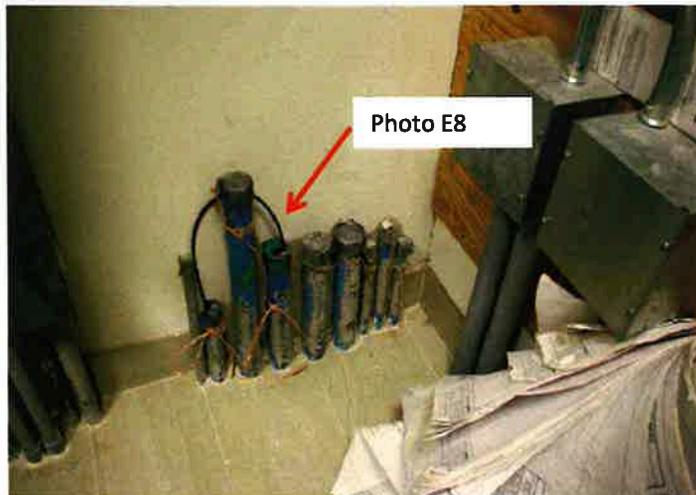
Photo No. E 7

Location: Clubhouse: Electrical Room

Remarks: Exposed wiring.

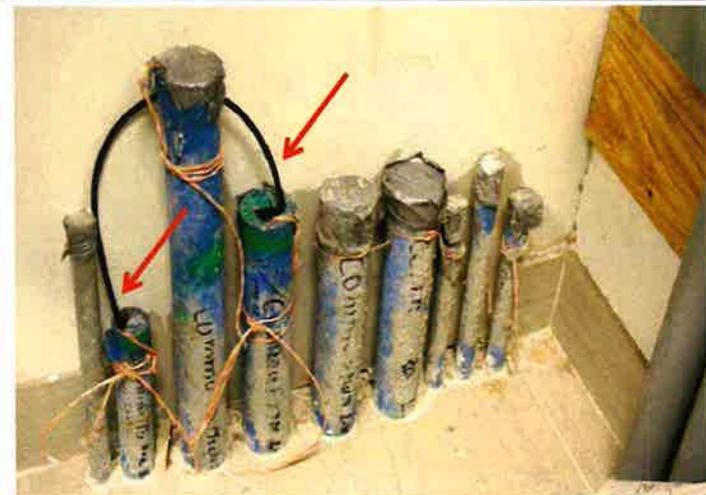
Photo No. E 8

Location: Clubhouse: Electrical Room

Remarks: Exposed wiring.

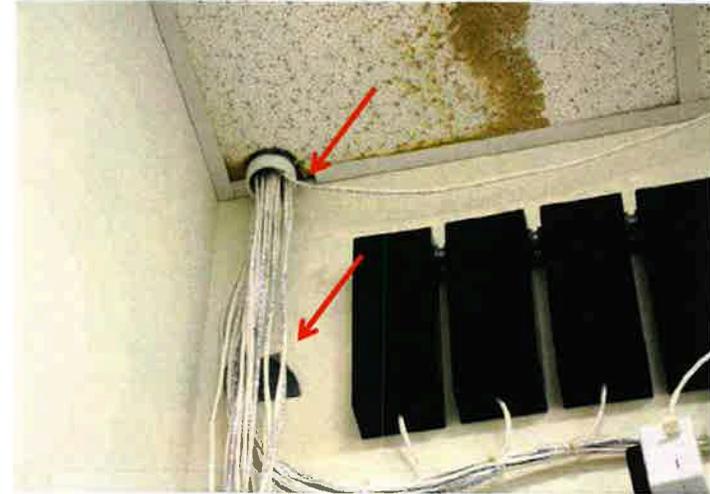
Photo No. E 10

Location: Clubhouse: Electrical Room

Remarks: Exposed wiring.

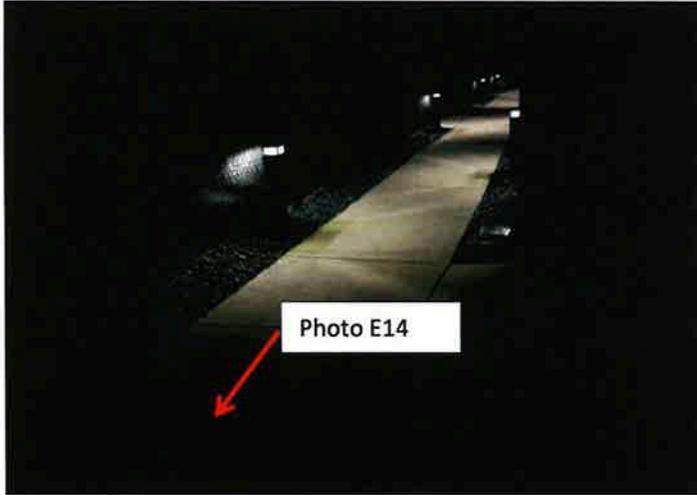
Photo No. E 13

Location: Pro Shop: Between North and Central Courts
Remarks: Inadequate illumination along means of egress.

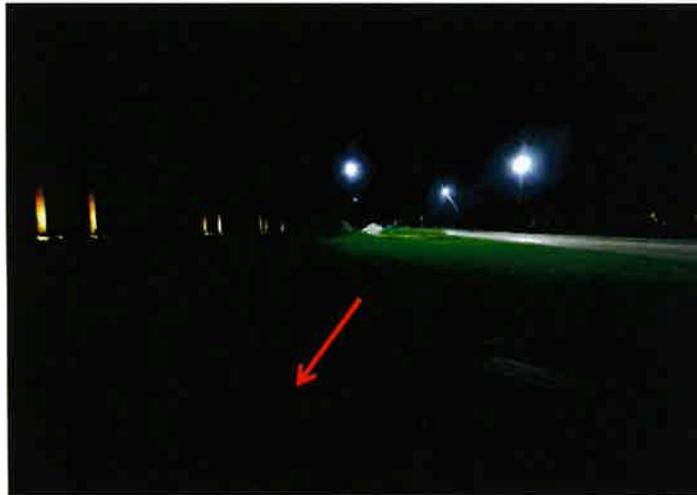
Photo No. E 15

Location: East Entrance: Select Locations at Sidewalk along Lyons Road
Remarks: Inadequate illumination.

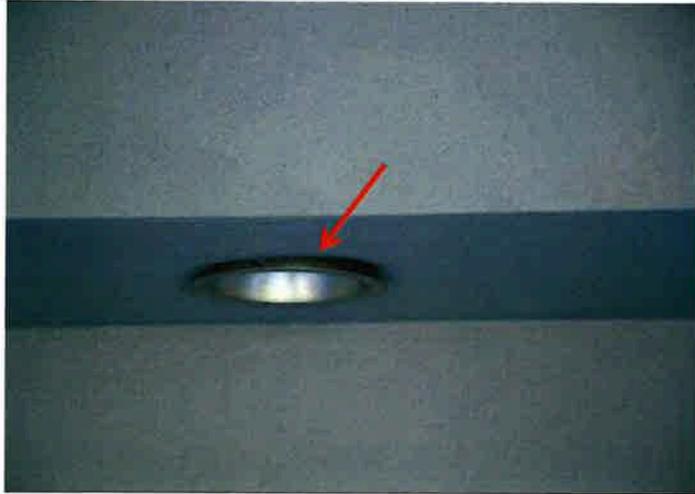
Photo No. E 17

39	Near Pro Shop: Ceiling Light Fixtures	Light fixtures are improperly installed.	Code Violation / Defect	Electrical	2014 Edition of NFPA 70 (NEC), Section 110.12.	E16, E17, E18
40	Tennis Court: Multiple Entrances	Missing screws on conduit.	Code Violation	Electrical	2014 Edition of NFPA 70 (NEC) Section 314.23 (A) Surface Mounting. 2014 Edition of NFPA 70 (NEC) Section 314.23 (B)(1) Nails and Screws.	E19, E20
41	West Gate Entrance: Guardhouse, Electrical Panel	Missing Switch.	Code Violation	Electrical	2014 Edition of NFPA 70 (NEC), Section 110.12.	E21

Location: Near Pro Shop: Ceiling Light Fixtures

Remarks: Light fixtures are improperly installed.

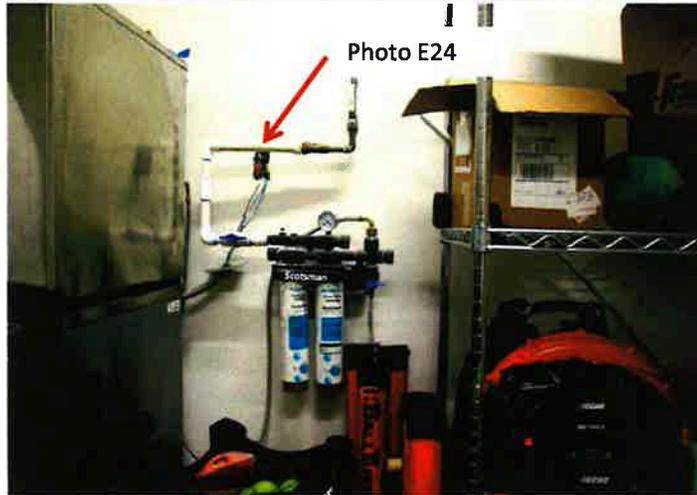
Photo No. E 23

43	<p>Pro Shop: 2-Golf Cart Garage/Storage</p>	Open electrical box and exposed wiring.	Code Violation	Electrical	<p>2014 Edition of NFPA 70 (NEC), Section 314.23 - (D)(2) Support Wires.</p> <p>2014 Edition of NFPA 70 (NEC), Section 314.17 (A) Openings to Be Closed.</p> <p>2014 Edition of NFPA 70 (NEC), Section 314.72 (C) Complete Enclosure.</p>	E23, E24, E25

Location: Pro Shop: 2-Golf Cart Garage/Storage

Remarks: Open electrical box and exposed wiring.

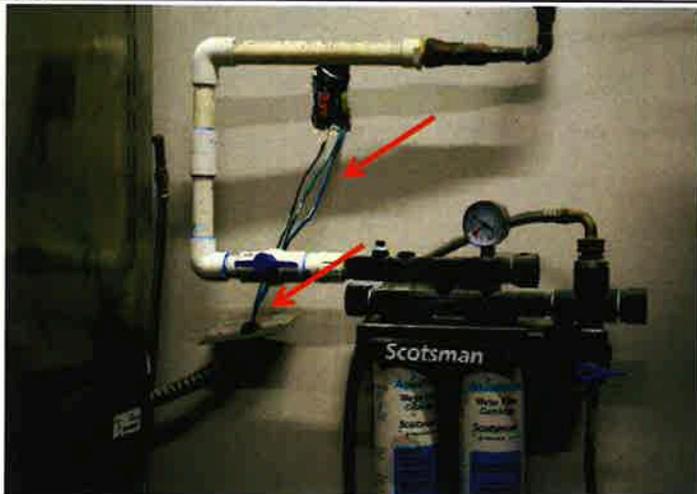
Photo No. E 25

Location: Pro Shop: 2-Golf Cart Garage/Storage

Remarks: Open electrical box and exposed wiring.

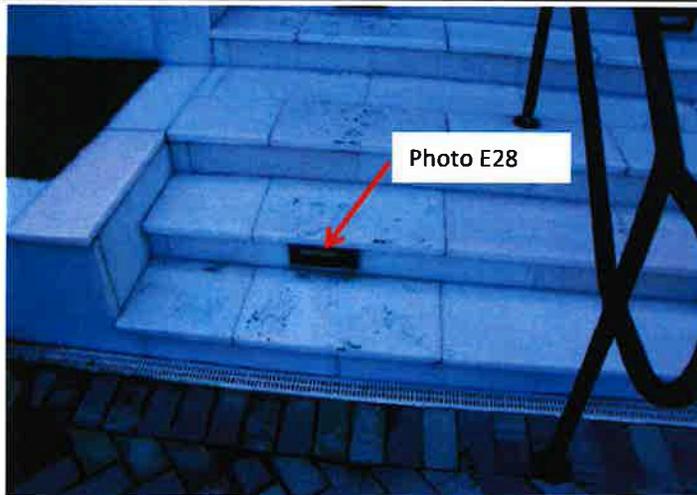
Photo No. E 27

Location: Pro Shop: West Stairs, Light Fixtures

Remarks: Signs of finish failure and water intrusion observed.

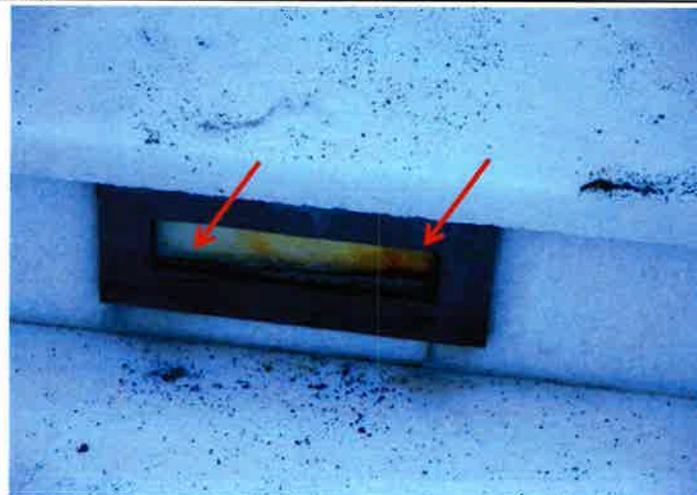
Photo No. E 28

Location: Pro Shop: West Stairs, Light Fixtures

Remarks: Signs of finish failure and water intrusion observed.

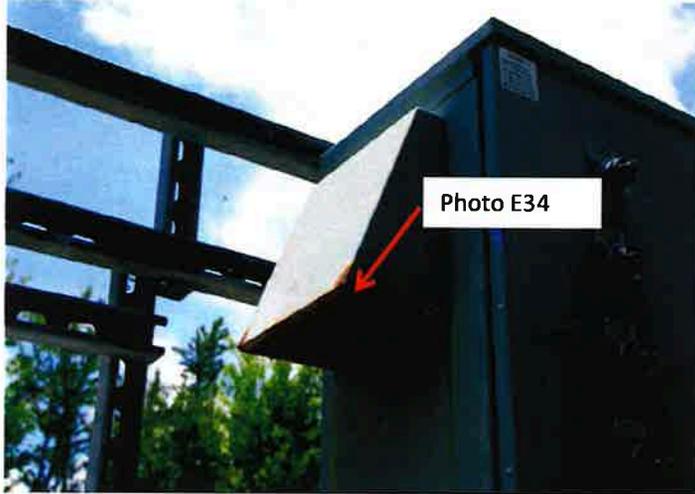
Photo No. E 33

47	East Gate Entrance: Fountain Equipment and Pump Area, Electrical Panel	Signs of finish failure.	Code Violation	Electrical	2014 Edition of NFPA 70 (NEC), Section 110.11 Deteriorating Agents. 2014 Edition of NFPA 70 (NEC), Section 110.12 (B) Mechanical Execution of Work. 2014 Edition of NFPA 70 (NEC), Section 344.10 (D). 2014 Edition of NFPA 70 (NEC), Section 314.72 Construction and Installation Requirements (A) Corrosion Protection.	E33, E34

Location: East Gate Entrance: Fountain Equipment and Pump Area, Electrical Panel

Remarks: Signs of finish failure.

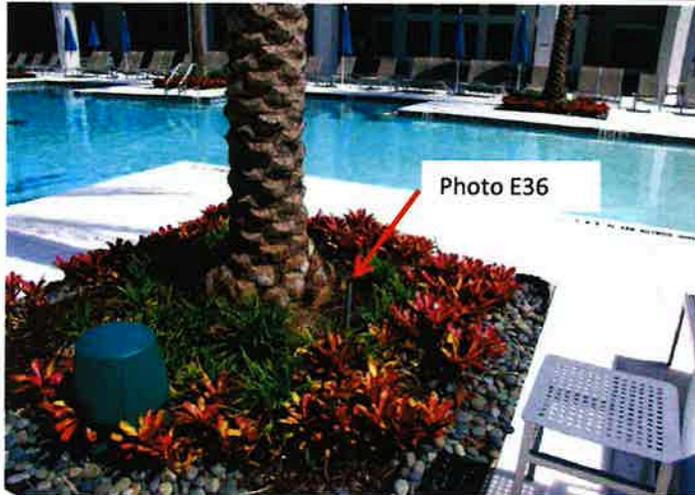
Photo No. E 35

Location: Pool Area: South, Near 1 ft 6 inch Mark

Remarks: Uncapped conduit.

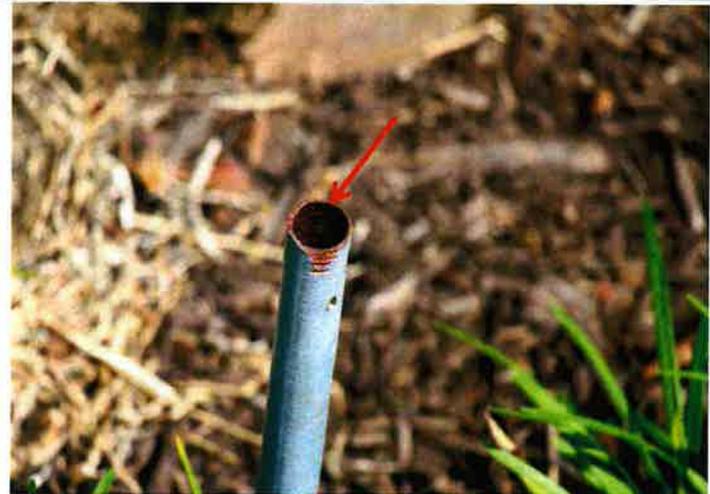
Photo No. E 36

Location: Pool Area: South, Near 1 ft 6 inch Mark

Remarks: Uncapped conduit.

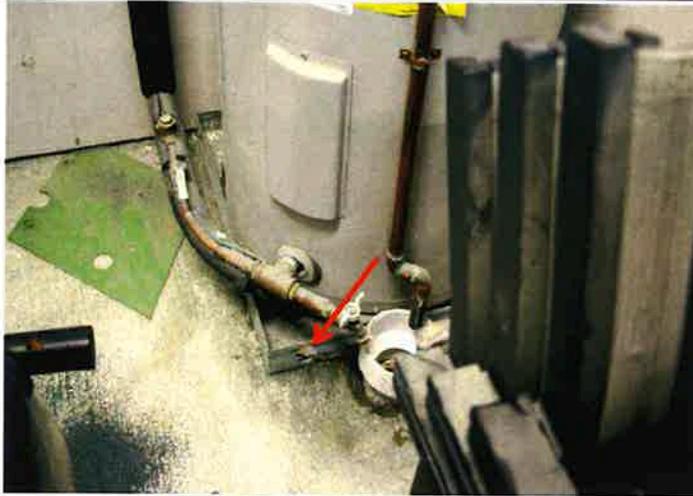
Photo No. PL 1

Location: Pro Shop: 2-Golf Cart Garage/Storage

Remarks: Auxiliary drain pan observed with a hole.

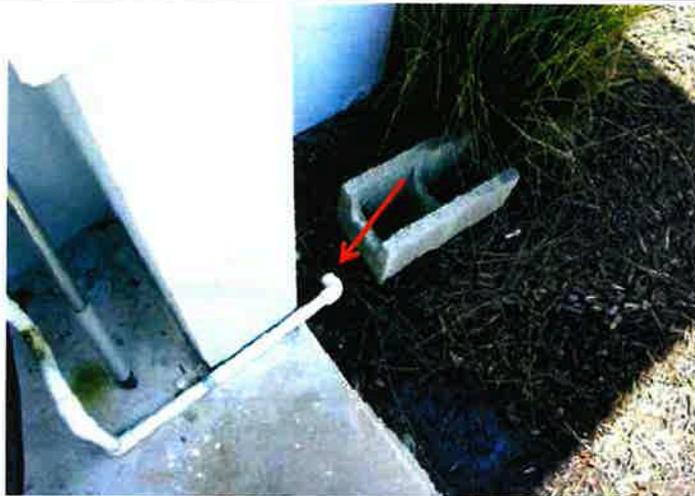
Photo No. PL 3

Location: East Gate Entrance: Guardhouse, Behind

Remarks: Improper drainage.

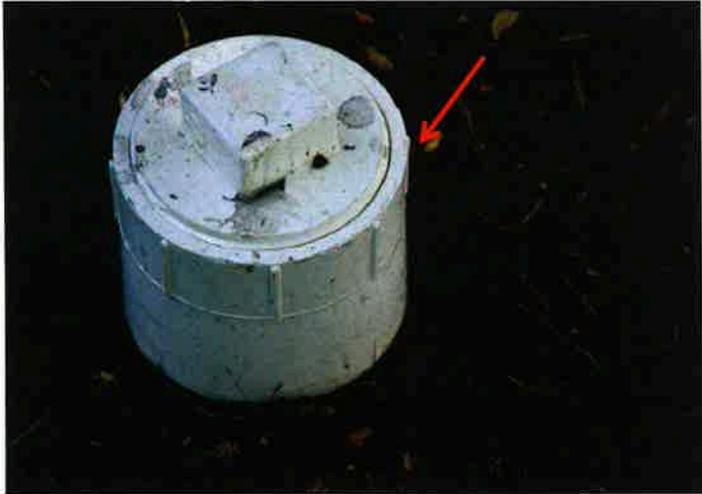
<p>Photo No. PL 5</p>

Remarks: Pipe stub out in the service path of the mechanical room.

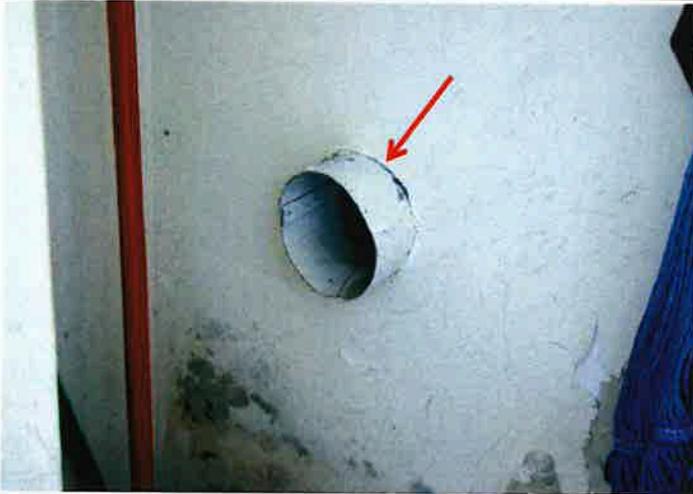
Photo No. PL 9

Location: Pool Area: Janitorial Closet

Remarks: Unsealed pipe penetration.

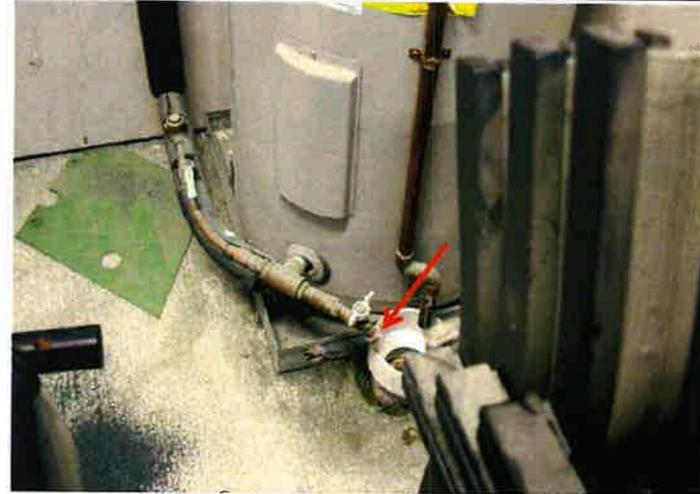
Photo No. PL 10

Line #	Location Description	Observation	Code Violation, Defect, Deviation, Improper Preturndown Maintenance	Potential Attributable Scope of Work	Criterion and Notes	Typical Photo
56	Pro Shop: 2-Golf Cart Garage/Storage	Water heater drain does not fully extend over drain.	Code Violation	Plumbing	2017 FBC - Plumbing, Chapter 3, Section 312.5 Water Supply System Test. 2017 FBC - Plumbing, Chapter 3, Section 301.3 Connections to Drainage System.	PL10

Location: Pro Shop: 2-Golf Cart Garage/Storage

Remarks: Water heater drain does not fully extend over drain.

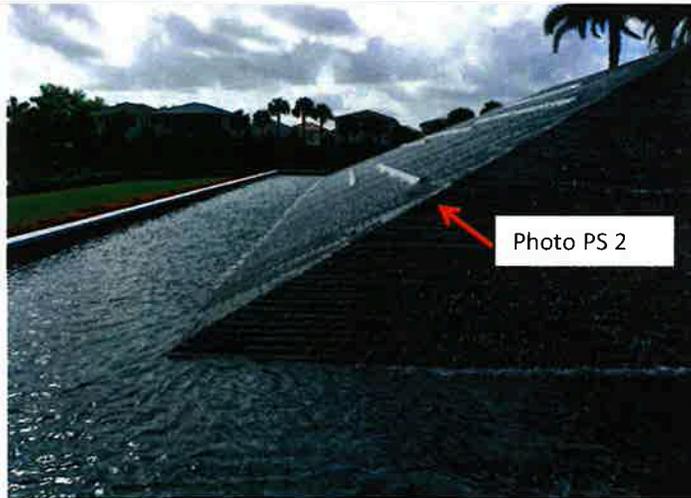
Photo No. PS 1

Line #	Location Description	Observation	Code Violation, Defect, Deviation, Improper Preturndown Maintenance	Potential Attributable Scope of Work	Criterion and Notes	Typical Photo
57	<p>East Entrance: South Pyramid Water Feature, Stone Tile (Typical Photo)</p> <p>East Entrance: North Pyramid Water Feature, Stone Tile</p>	<p>Debonded tiles in select locations. Previous repairs evident.</p>	<p>Code Violation / Deviation</p>	<p>Pool, Spa, and Water Features</p>	<p>TCNA Handbook for Ceramic, Glass and Stone Tile Installation: Mortar Coverage for Natural Stone: "In dry and wet areas, the minimum coverage is 95% with no voids exceeding 2 square inches and no voids within 2" of tile corners. All corners and edges of the stone tiles must be fully supported...".</p> <p>ANSI 108.5 -1999 Installation of Ceramic Tile with Dry-Set Portland Cement Mortar or Latex-Portland Cement Mortar.</p> <p>Adequate mortar material should be selected for a given set of conditions (i.e. water resistance). Inadequate mortars will degrade upon prolonged exposure to moisture.</p>	<p>PS1, PS2</p>

Location: East Entrance: South Pyramid Water Feature, Stone Tile

Remarks: Debonded tiles in select locations. Previous repairs evident.

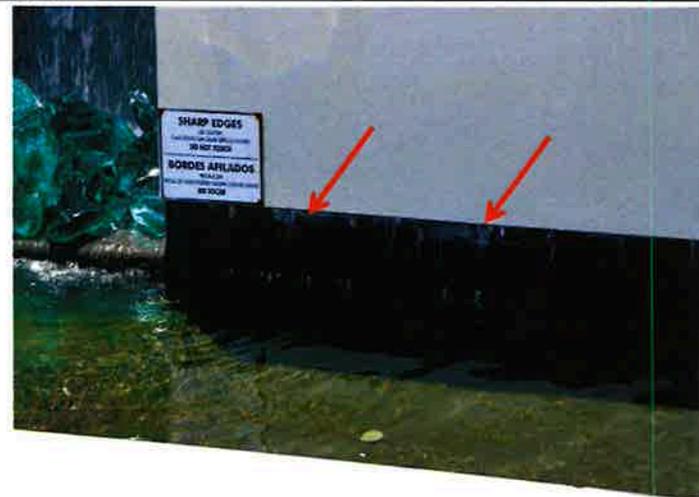
Photo No. PS 4

58	<p>East Entrance: South Water Feature, Tile (Typical Photo)</p> <p>East Entrance: South Pyramid Water Feature, Tile</p> <p>East Entrance: North Water Feature, Tile</p>	<p>Efflorescence evident.</p>	<p>Code Violation / Deviation</p>	<p>Pool, Spa, and Water Features</p>	<p>2017 FBC - Building, Section 2103.2.3 and 2103.2.3.1</p> <p>ANSI A108.5-1999, Installation of ceramic tile with dry-set portland cement mortar or latex-portland cement mortar, Section A-4.3.2.3.4, Average contact area shall be not less than 80% except on exterior or shower installations where contact area shall be 95%</p> <p>Adequate mortar material should be selected for a given set of conditions (i.e. water resistance). Inadequate mortars will degrade upon prolonged exposure to moisture.</p>	<p>PS3, PS4</p>

Location: East Entrance: South Water Feature, Tile

Remarks: Efflorescence evident.

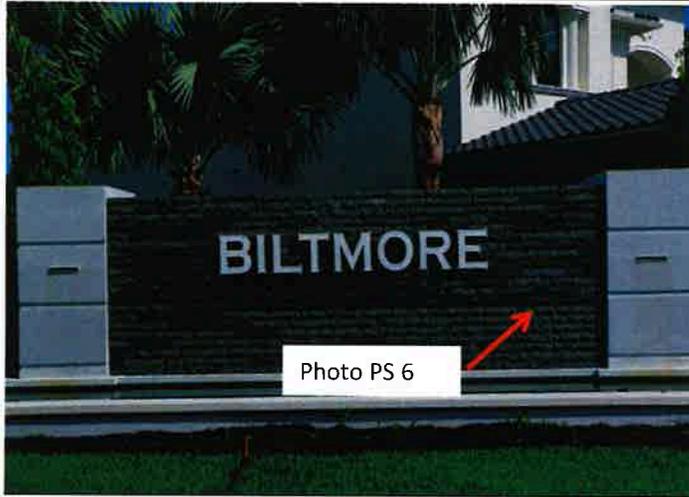
Photo No. PS 5

Location: Biltmore: Water Feature, Tile

Remarks: No movement joint in field.

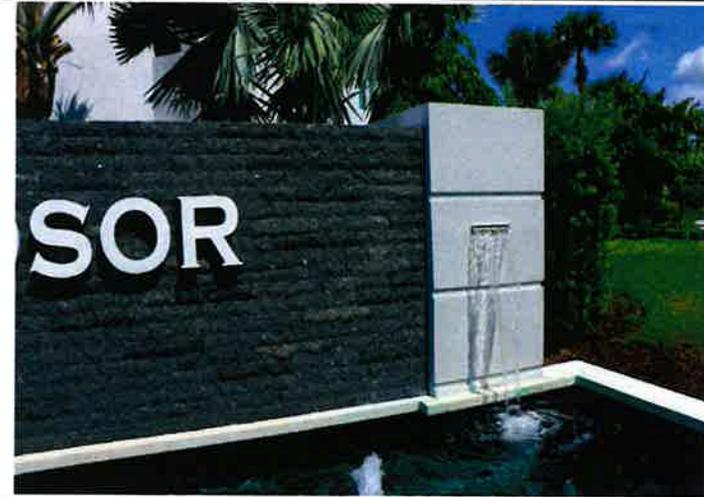
Photo No. PS 6

Location: Windsor: Water Feature, Tile

Remarks: No movement joint in field.

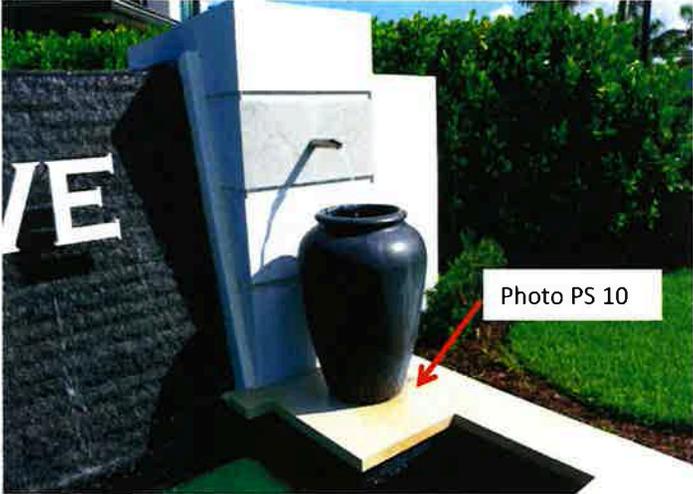
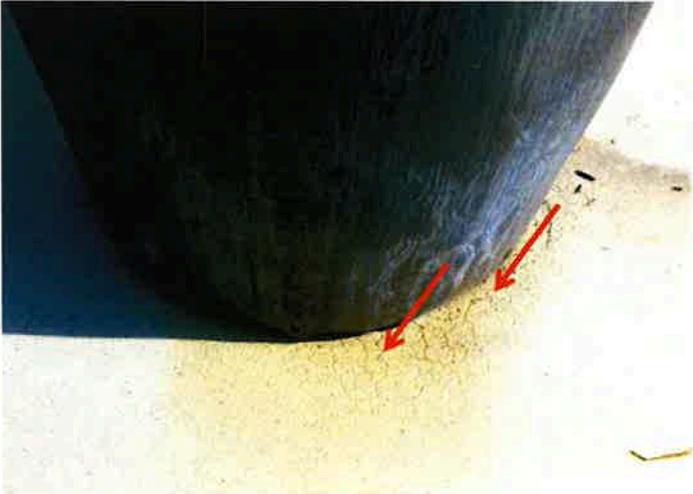
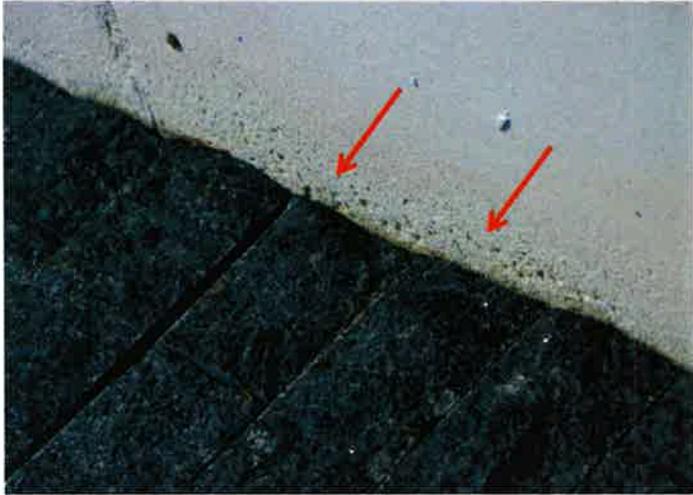
61	The Enclave: Water Feature, Vase Drain East Entrance: North Pyramid Water Feature, Wall	Surface deteriorating.	Defect	Pool, Spa, and Water Features	System is not performing as intended.	PS9, PS10, PS11, PS12
62	East Entrance: South Pyramid Water Feature, Basin, Surface	Crack(s).	Defect	Pool, Spa, and Water Features	System is not performing as intended.	PS13, PS14
63	Biltmore: Water Feature, Spout	Spout not properly sealed. Leak(s) evident.	Defect	Pool, Spa, and Water Features	Workmanship shall be sound, secure, and complete.	PS15, PS16

<p>Location: The Enclave: Water Feature, Vase Drain</p> <p>Remarks: Surface deteriorating.</p>	<p>Location: The Enclave: Water Feature, Vase Drain</p> <p>Remarks: Surface deteriorating.</p>
<p>Photo No. PS 11</p>

<p>Location: East Entrance: North Pyramid Water Feature, Wall</p> <p>Remarks: Surface deteriorating.</p>	<p>Location: East Entrance: North Pyramid Water Feature, Wall</p> <p>Remarks: Surface deteriorating.</p>

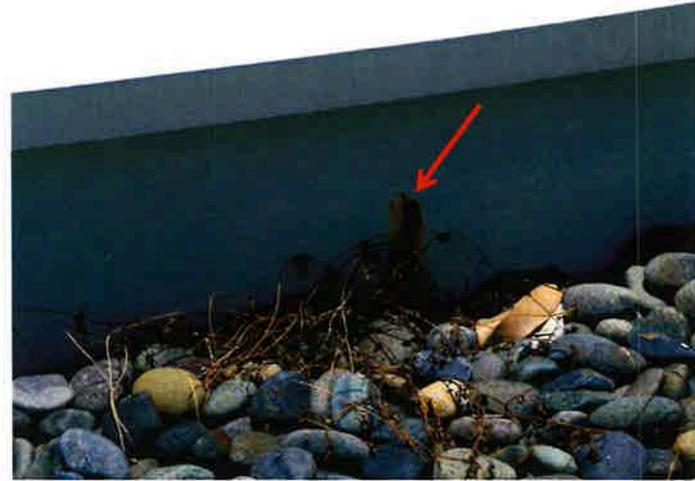
Photo No. PS 18

Location: East Entrance: South Pyramid, Perimeter Wall

Remarks: Corrosion evident.

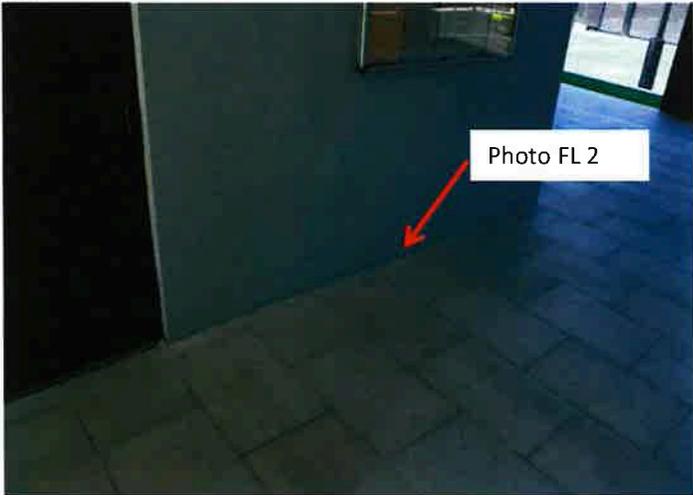
<p>Location: Pro Shop: Tile (Throughout)</p> <p>Remarks: Movement joints not installed at restraining surfaces.</p>	<p>Location: Pro Shop: Tile (Throughout)</p> <p>Remarks: Movement joints not installed at restraining surfaces.</p>
<p>Photo No. FL 3</p>

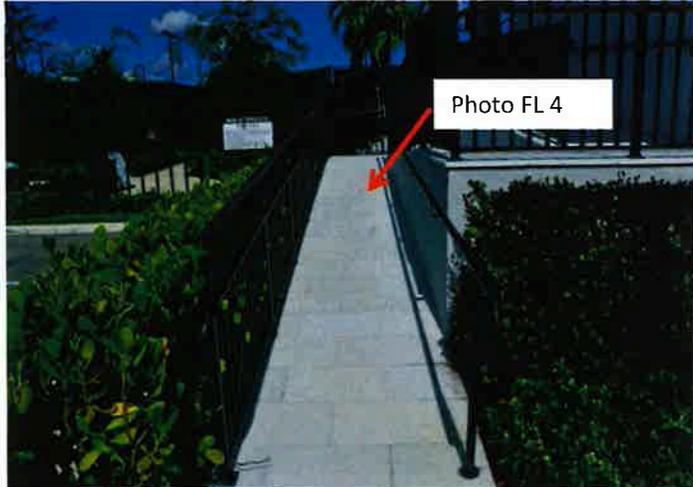
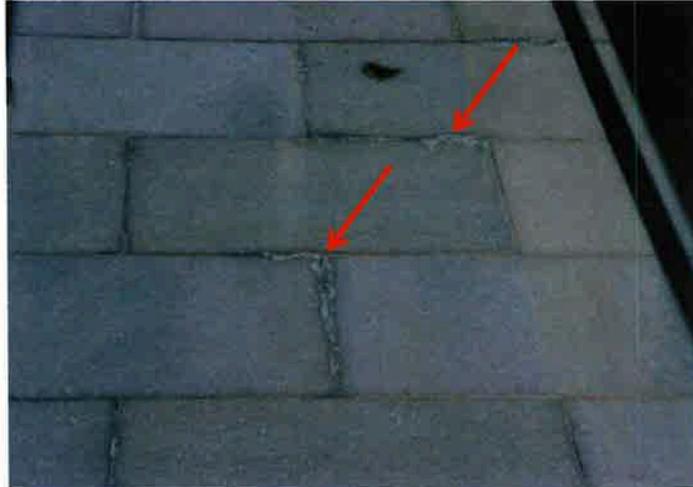
<p>Location: Pro Shop: South Ramp, Tile</p> <p>Remarks: Efflorescence is evident.</p>	<p>Location: Pro Shop: South Ramp, Tile</p> <p>Remarks: Efflorescence is evident.</p>
