COMPLAINT

**Re: Boca Bridges Homeowners' Association, Inc.
Property Condition Assessment 558 Report**

Boca Bridges - Communities

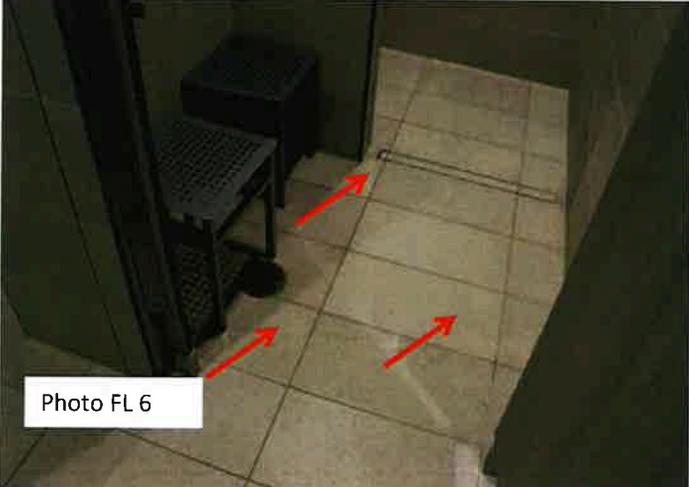
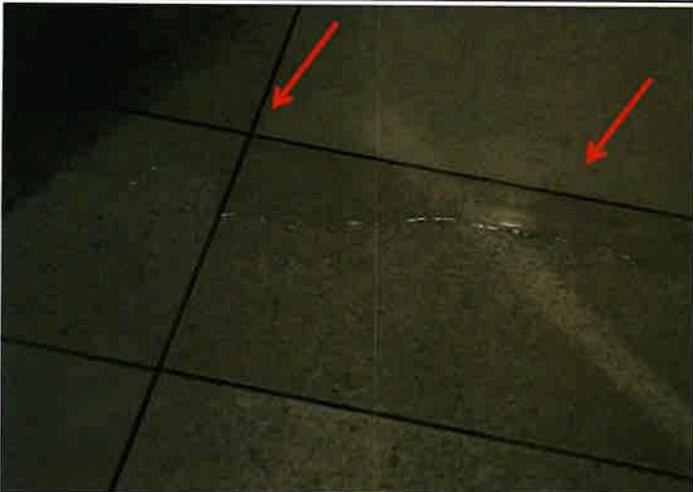
82	Clubhouse: Men's Locker Room, Shower Area Clubhouse: Women's Locker Room, Shower Area (Typical Photo)	Floors do not properly slope to drain. Ponding water evident.	Code Violation	Flooring	2017 FBC - Accessibility, Section 302.1, Floor and ground surfaces shall be stable, firm, and slip resistant.	F5, F6

<p>Location: Clubhouse: Women's Locker Room, Shower Area</p> <p>Remarks: Floors do not properly slope to drain. Ponding water evident.</p>	<p>Location: Clubhouse: Women's Locker Room, Shower Area</p> <p>Remarks: Floors do not properly slope to drain. Ponding water evident.</p>
<p>Photo No. FL 7</p>

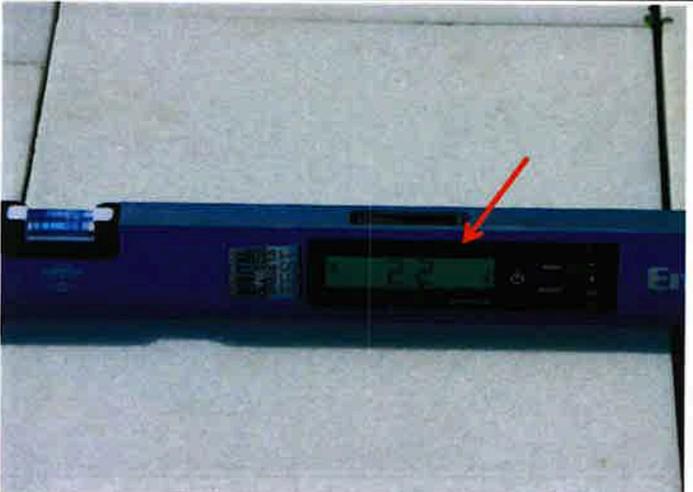
Line #	Location Description	Observation	Code Violation, Defect, Deviation, Improper Preturndover Maintenance	Potential Attributable Scope of Work	Criterion and Notes	Typical Photo
83	Clubhouse: Main Pool, Deck	Improper slope of pool deck.	Code Violation	Flooring	2017 FBC - Building, Section 454.1.3.1.2: Pool wet decks shall be uniformly sloped at a minimum of 2 percent to a maximum of 4 percent away from the pool or to deck drains to prevent standing water.	F7, F8, F9, F10

<p>Location: Clubhouse: Main Pool, Deck</p> <p>Remarks: Improper slope of pool deck.</p>	<p>Location: Clubhouse: Main Pool, Deck</p> <p>Remarks: Improper slope of pool deck.</p>

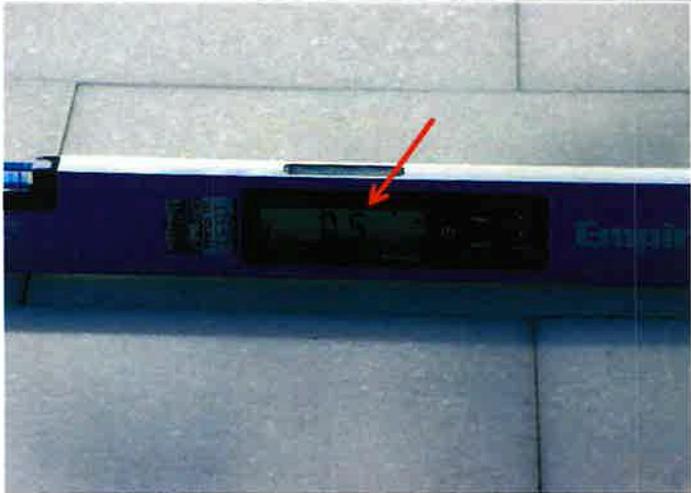
<p>Location: Clubhouse: Main Pool, Deck</p> <p>Remarks: Improper slope of pool deck.</p>	<p>Location: Clubhouse: Main Pool, Deck</p> <p>Remarks: Improper slope of pool deck.</p>

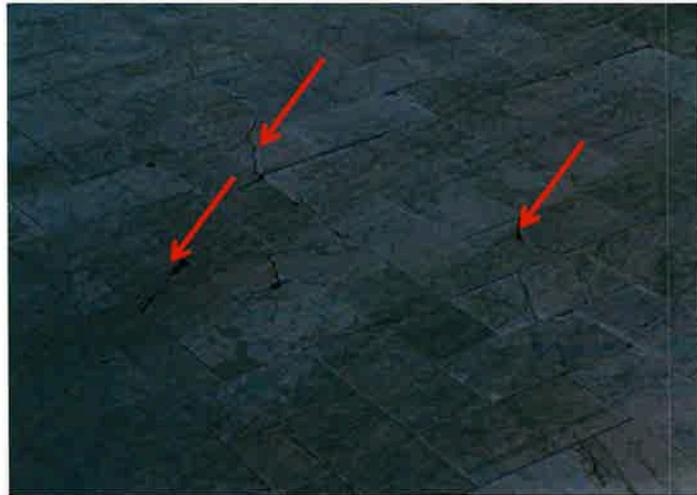
Photo No. PV 4

Location: Cedarbrook: 17417 Ponte Chiasso Drive

Remarks: Crack(s).

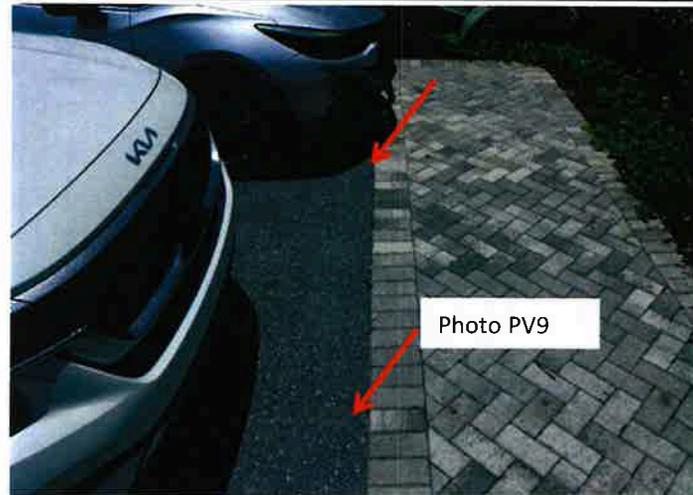
Photo No. PV 8

Location: East Guardhouse: Pavers
Remarks: Edge restraint missing. Pavers in contact with asphalt.

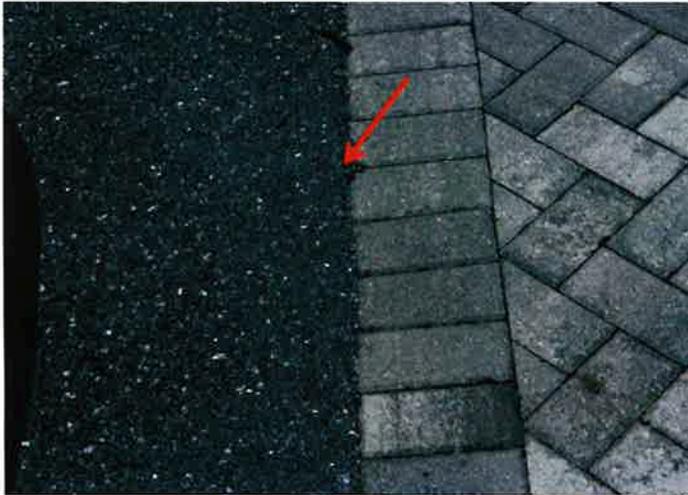
Photo No. PV 9

Location: East Guardhouse: Pavers
Remarks: Edge restraint missing. Pavers in contact with asphalt.

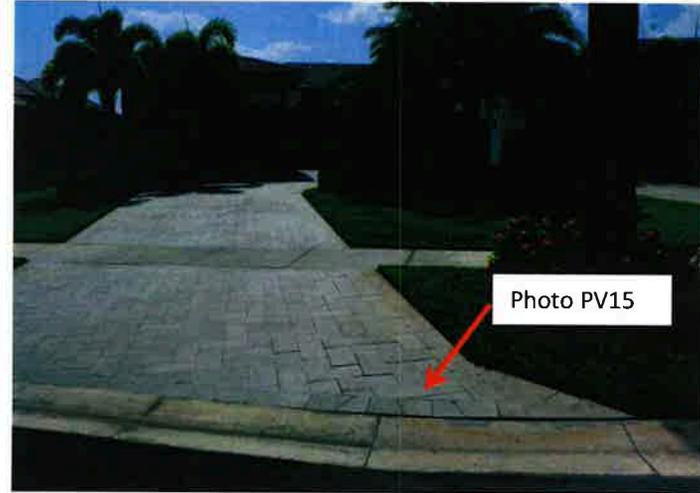
Photo No. PV 14

Location: Lakewood: 17127 Brulee Breeze Way

Remarks: Pavers are settling unevenly.

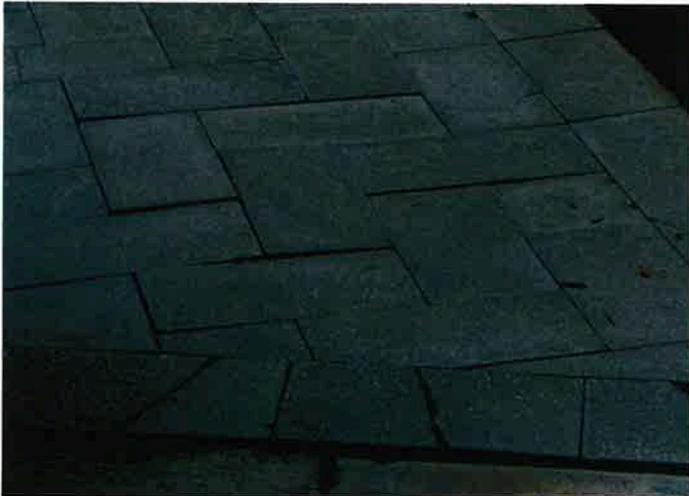
Photo No. PV 15

Location: Lakewood: 17127 Brulee Breeze Way

Remarks: Pavers are settling unevenly.

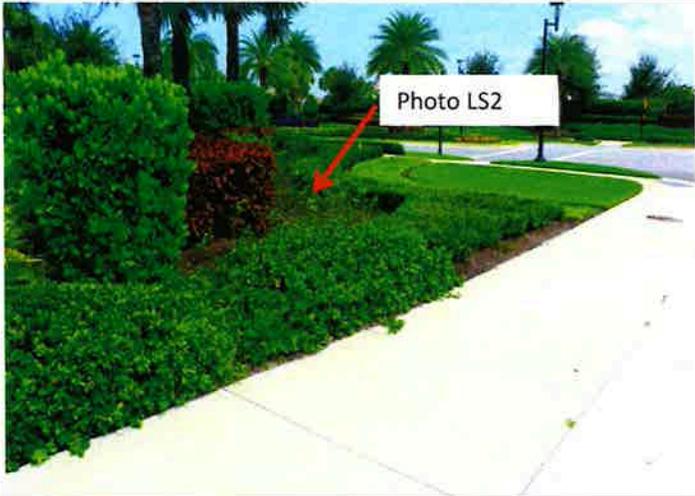
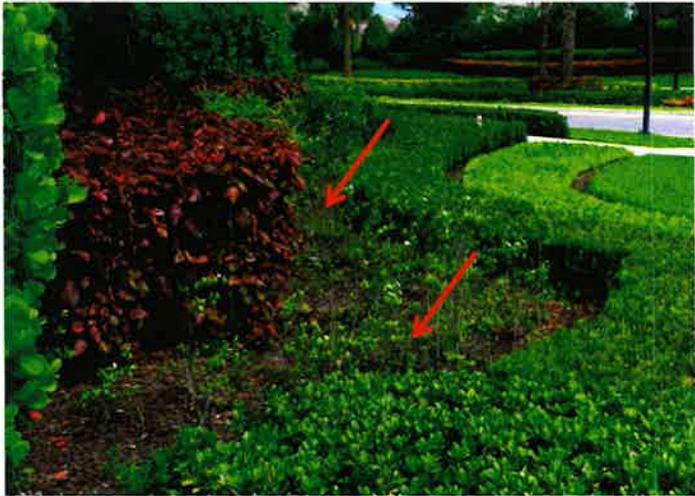
<p>Location: Lakewood: Entrance</p> <p>Remarks: Landscaping not thriving.</p>	<p>Location: Lakewood: Entrance</p> <p>Remarks: Landscaping not thriving.</p>
<p>Photo No. LS 3</p>

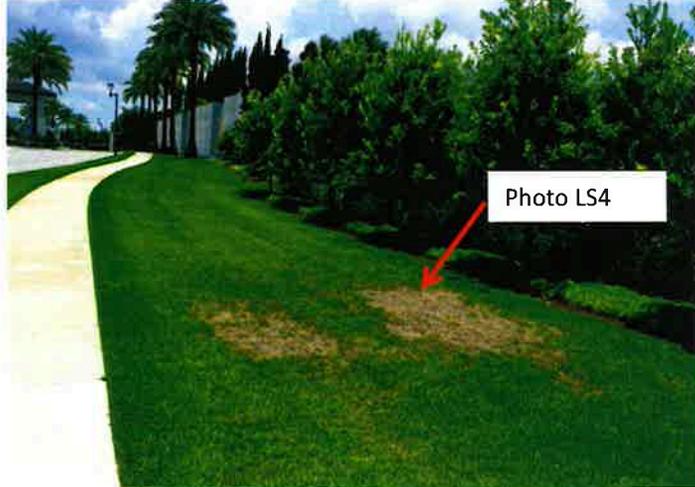
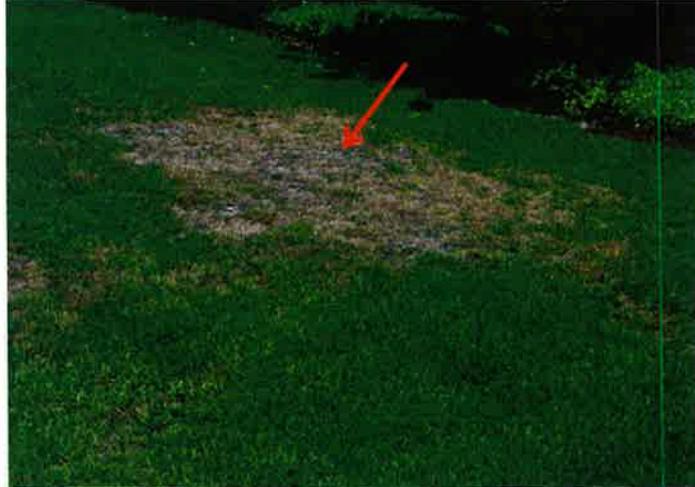
<p>Location: East Entrance: Near North Pyramid, Lawn</p> <p>Remarks: Sod not thriving.</p>	<p>Location: East Entrance: Near North Pyramid, Lawn</p> <p>Remarks: Sod not thriving.</p>

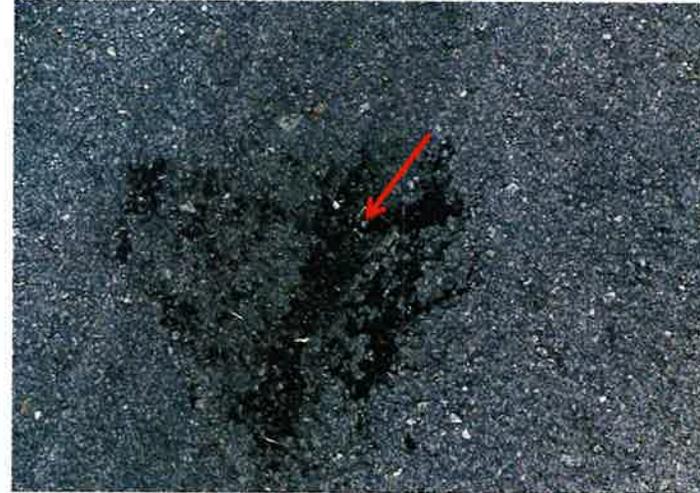
Photo No. PA 2

Location: Lakewood: Roundabout Near 17115 Brulee Breeze Way, Pavement

Remarks: Deterioration of asphalt.

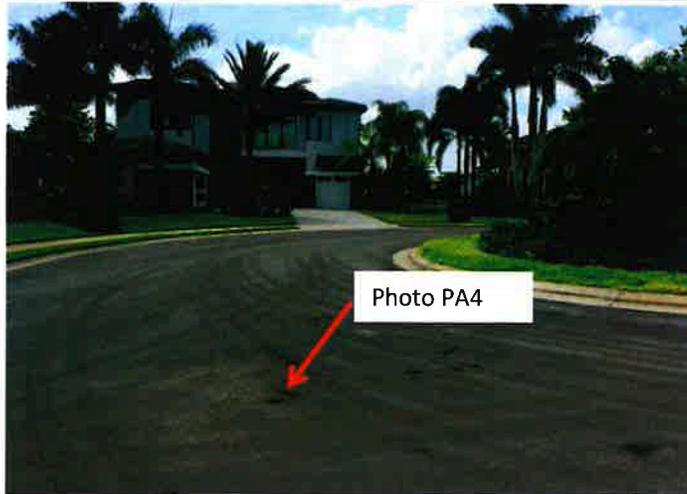
Photo No. PA 3

Location: Briarwood: Roundabout at the end of Ludovica Lane, Pavement

Remarks: Deterioration of asphalt.

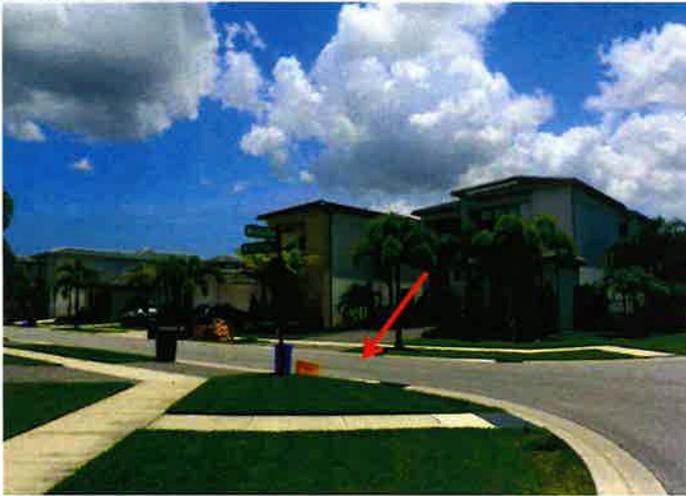
Photo No. PA 5

Line #	Location Description	Observation	Code Violation, Defect, Deviation, Improper Pretturnover Maintenance	Potential Attributable Scope of Work	Criterion and Notes	Typical Photo
94	<p>Cambridge: Intersection of Biaggio Road and Rosella Road</p> <p>Waldorf: Intersection of Santaluce Manor and Chauvet Way</p> <p>Waldorf: Intersection of Santaluce Manor and Dulcetto Court (Typical Photo)</p> <p>Rosewood: Intersection of Abruzzo Avenue and Fiano Place</p> <p>Rosewood: Intersection of Abruzzo Avenue and Benedetta Place</p> <p>Windsor: Intersection of Cappucino Way and Espresso Manor (Typical Photo)</p> <p>Brookside: Intersection of Ristretto Trail and Macchiato Avenue</p> <p>Brookside: Intersection of Ristretto Trail and Vescovato Way</p>	Stop sign pavement markings not installed.	Deviation / Defect	Pavement	FDOT Manual on Uniform Traffic Control Devices: Part 3, Section 3B.16 Stop and Yield Lines.	PA5, PA6

Location: Waldorf: Intersection of Santaluce Manor and Dulcetto Court

Remarks: Stop sign pavement markings not installed.

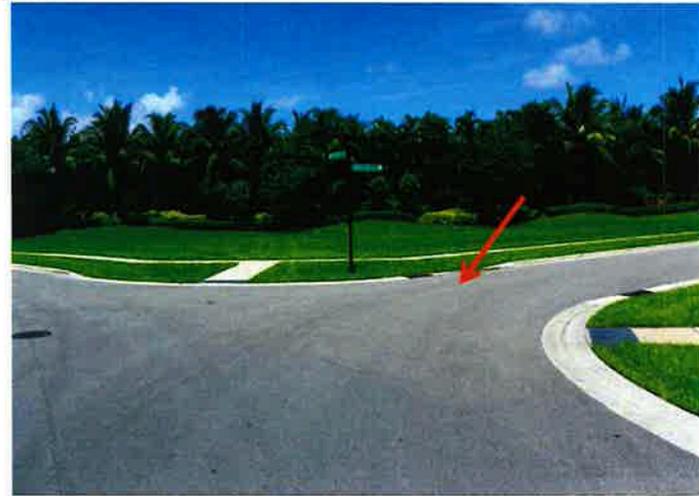
Photo No. PA 6

Location: Windsor: Intersection of Cappuccino Way and Espresso Manor

Remarks: Stop sign pavement markings not installed.

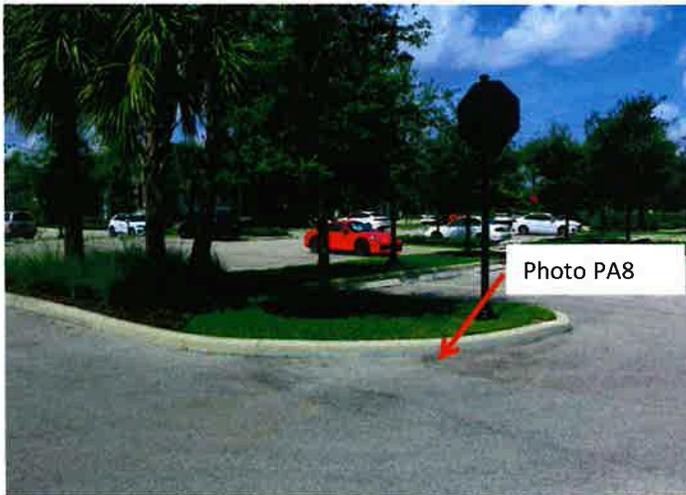
Photo No. PA 7

Location: Clubhouse: Parking Lot, East Side, Near Curb

Remarks: Crack(s).

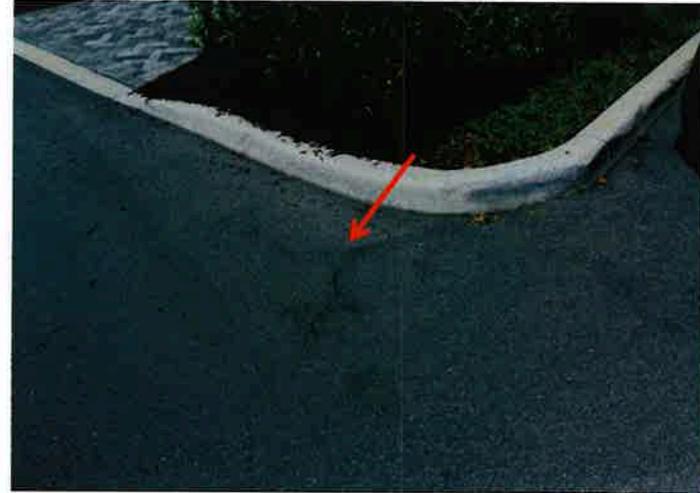
Photo No. PA 10

Line #	Location Description	Observation	Code Violation, Defect, Deviation, Improper Pretreatment Maintenance	Potential Attributable Scope of Work	Criterion and Notes	Typical Photo
95	Pro Shop: East Elevation, Pavement Clubhouse: Parking Lot, East Side, Near Curb (Typical Photo)	Crack(s).	Deviation / Defect	Pavement	U.S. Dep. Of Transportation, Federal Highway Administration - Geotechnical Aspects of Pavements, Section 1.3 The Pavement System and Typical Pavement Types, P. 1-7 and 1-8: "In addition to providing a significant fraction of the overall structural capacity of the pavement, the surface layer must minimize the infiltration of surface water, provide a smooth, uniform, and skid-resistant riding surface, and offer durability against traffic abrasion and the climate."	PA7, PA8
96	Pro Shop: East Elevation, Parking Lot	Crack(s).	Deviation / Defect	Pavement	U.S. Dep. Of Transportation, Federal Highway Administration - Geotechnical Aspects of Pavements, Section 1.3 The Pavement System and Typical Pavement Types, P. 1-7 and 1-8: "In addition to providing a significant fraction of the overall structural capacity of the pavement, the surface layer must minimize the infiltration of surface water, provide a smooth, uniform, and skid-resistant riding surface, and offer durability against traffic abrasion and the climate." Asphalt should be protected against damage by roots.	PA9, PA10

Location: Pro Shop: East Elevation, Parking Lot

Remarks: Crack(s).

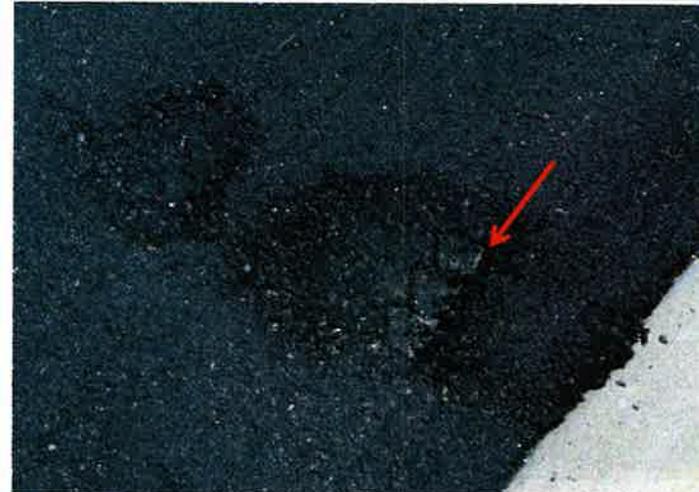
Photo No. PA 12

Line #	Location Description	Observation	Code Violation, Defect, Deviation, Improper Pretreatment Maintenance	Potential Attributable Scope of Work	Criterion and Notes	Typical Photo
97	Rosewood: 9053 Benedetta Place The Enclave: Roundabout at the end of Carretto Court Biltmore: Roundabout Near 9691 Chianti Classico Terrace, Pavement (Typical Photo) Windsor: Roundabout at the end of Cappuccino Way, Pavement	Deformation of the asphalt.	Deviation / Defect	Pavement	U.S. Dep. Of Transportation, Federal Highway Administration - Geotechnical Aspects of Pavements, Section 1.3 The Pavement System and Typical Pavement Types, P. 1-7 and 1-8: "In addition to providing a significant fraction of the overall structural capacity of the pavement, the surface layer must minimize the infiltration of surface water, provide a smooth, uniform, and skid-resistant riding surface, and offer durability against traffic abrasion and the climate."	PA11, PA12

Location: Biltmore: Roundabout Near 9691 Chianti Classico Terrace, Pavement

Remarks: Deformation of the asphalt.

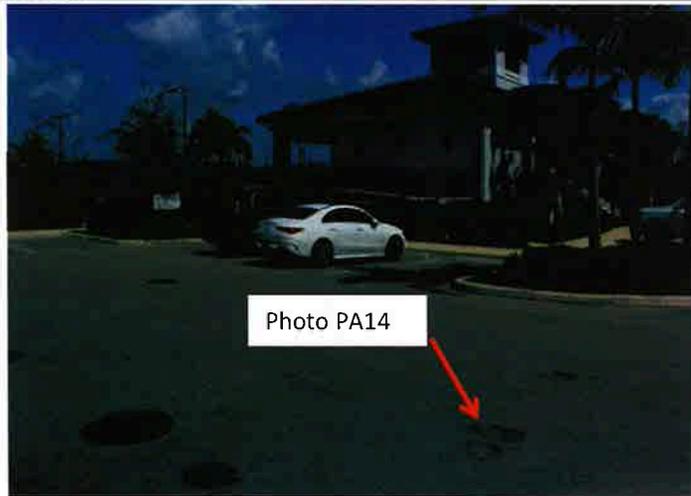
Photo No. PA 13

Location: Clubhouse: Parking Lot, West Side, Near Handicap Spots

Remarks: Depression in road surface.

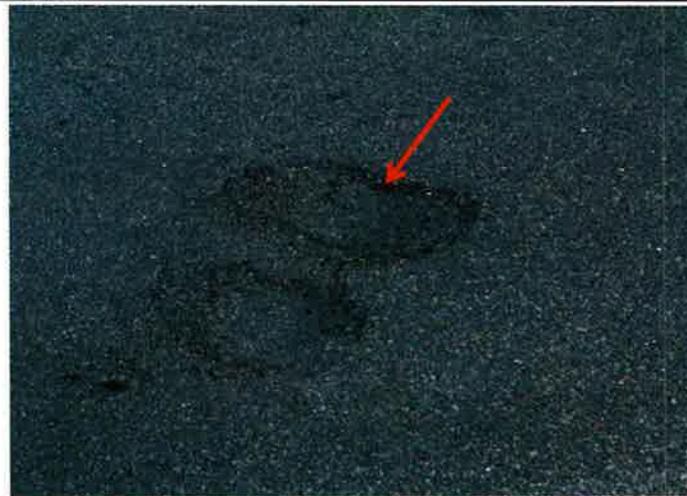
Photo No. PA 14

Location: Clubhouse: Parking Lot, West Side, Near Handicap Spots

Remarks: Depression in road surface.

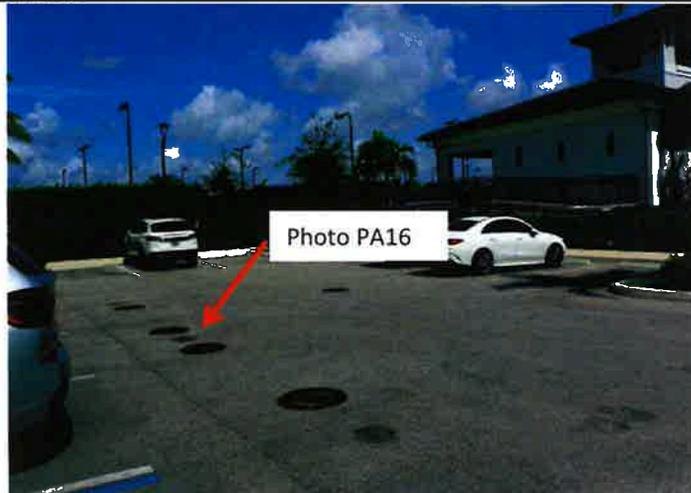
Photo No. PA 15

Location: Clubhouse: Parking Lot, West Side, Near Handicap Spots, Utility Cover(s)

Remarks: Low drain cover.

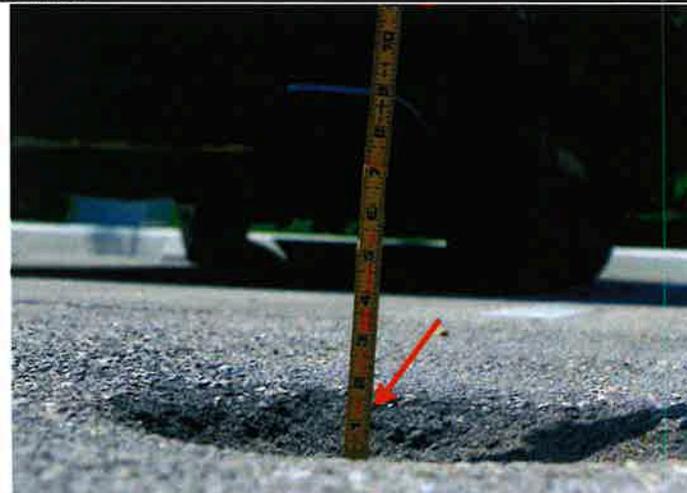
Photo No. PA 16

Location: Clubhouse: Parking Lot, West Side, Near Handicap Spots, Utility Cover(s)

Remarks: Low drain cover.

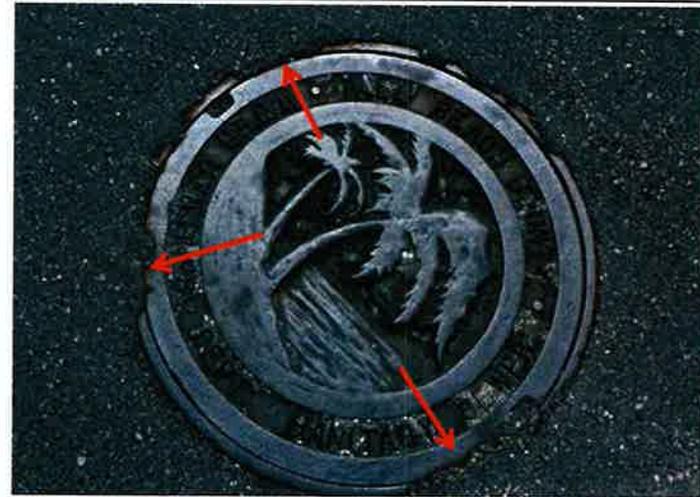
Photo No. PA 18

Location: Biltmore: Near Sauvignon Parkway, Manhole Cover

Remarks: Manhole cover(s) encased in pavement.

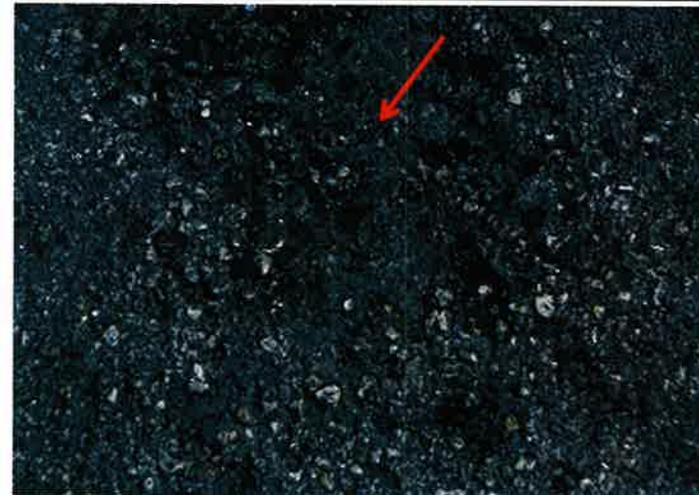
Photo No. PA 20

Line #	Location Description	Observation	Code Violation, Defect, Deviation, Improper Pretreatment Maintenance	Potential Attributable Scope of Work	Criterion and Notes	Typical Photo
100	<p>Biltmore: Near Sauvignon Parkway, Manhole Cover</p> <p>Biltmore: 9618 Chianti Classico Terrace, Manhole Cover</p>	Manhole cover(s) encased in pavement.	Defect	Pavement	Workmanship shall be sound, secure, and complete.	PA17, PA18
101	<p>Clubhouse: Parking Lot, Near Outdoor Basketball Court</p> <p>Sauvignon Parkway: Median Near Biltmore, Pavement</p> <p>Biltmore: Roundabout Near 9691 Chianti Classico Terrace, Pavement (Typical Photo)</p>	Raveling of asphalt.	Deviation / Defect	Pavement	<p>U.S. Dep. Of Transportation, Federal Highway Administration - Geotechnical Aspects of Pavements, Section 1.3 The Pavement System and Typical Pavement Types, P. 1-7 and 1-8: "In addition to providing a significant fraction of the overall structural capacity of the pavement, the surface layer must minimize the infiltration of surface water, provide a smooth, uniform, and skid-resistant riding surface, and offer durability against traffic abrasion and the climate."</p> <p>FDOT Flexible Pavement Design Manual.</p>	PA19, PA20

Location: Biltmore: Roundabout Near 9691 Chianti Classico Terrace, Pavement

Remarks: Raveling of asphalt.

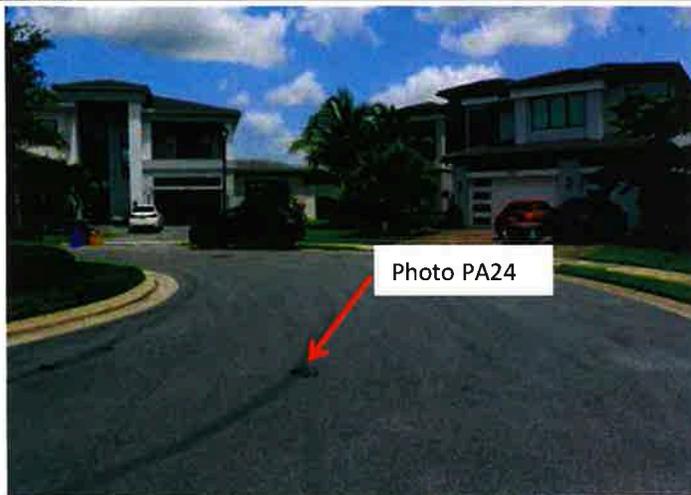
Photo No. PA 23

103	<p>Cambridge: Roundabout at the end of Rosella Road (Typical Photo)</p>	Slippage of the asphalt.	Deviation / Defect	Pavement	<p>U.S. Dep. Of Transportation, Federal Highway Administration - Geotechnical Aspects of Pavements, Section 1.3 The Pavement System and Typical Pavement Types, P. 1-7 and 1-8: "In addition to providing a significant fraction of the overall structural capacity of the pavement, the surface layer must minimize the infiltration of surface water, provide a smooth, uniform, and skid-resistant riding surface, and offer durability against traffic abrasion and the climate."</p>	PA23, PA24

Location: Cambridge: Roundabout at the end of Rosella Road

Remarks: Slippage of the asphalt.

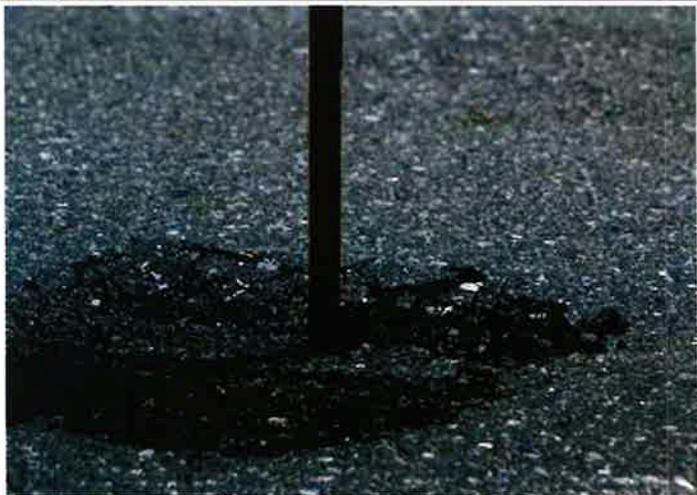
Photo No. PA 24

Location: Cambridge: Roundabout at the end of Rosella Road

Remarks: Slippage of the asphalt.

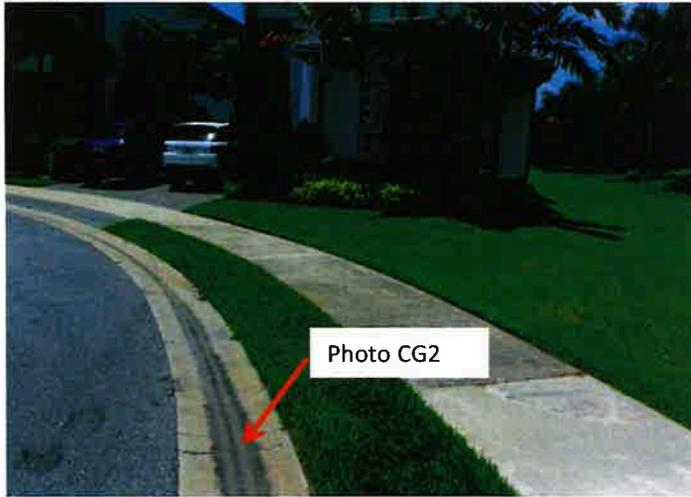
Photo No. CG 1

Location: Waldorf: 8987 Dulcetto Court, Gutter

Remarks: Crack(s). Spalls evident in select locations.

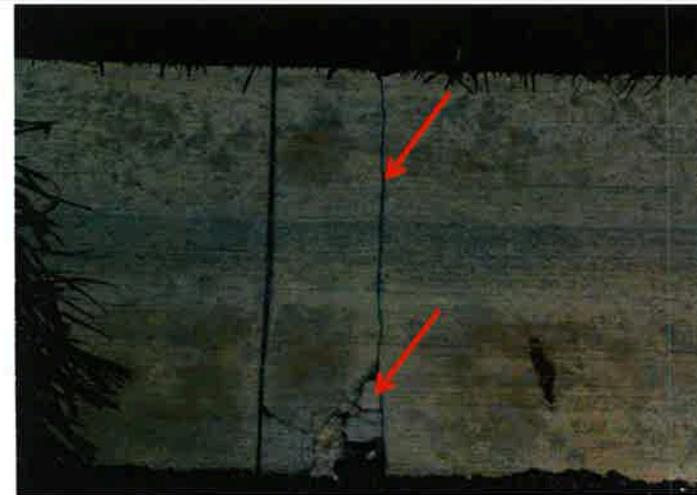
Photo No. CG 4

Location: Windsor: 17128 Cappuccino Way, Gutter

Remarks: Crack(s). Spalls evident in select locations.

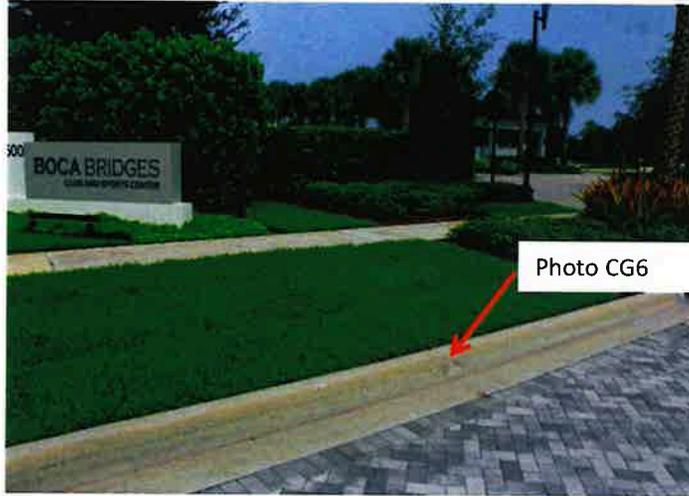
Photo No. CG 5

Line #	Location Description	Observation	Code Violation, Defect, Deviation, Improper Preturndover Maintenance	Potential Attributable Scope of Work	Criterion and Notes	Typical Photo
104	Cambridge: 17412 and 17359 Rosella Road, Gutter Waldorf: 9041, 9017, 9000, and 8987 (Typical Photo) Dulcetto Court, Gutter Rosewood: 17111 Abruzzo Avenue, Gutter Rosewood: 9084 Benedetta Place, Gutter Lakewood: 17218 Brulee Breeze Way, Gutter Windsor: 9924 and 9964 Espresso Manor, Gutter Windsor: 17128 (Typical Photo), 17096, and 17073 Cappuccino Way, Gutter Brookside: 9624 Macchiato Avenue, Gutter	Crack(s). Spalls evident in select locations.	Deviation / Defect	Curb and Gutter	FDOT Design Standards: Index 300, Sheet 2 of 2, Contraction Joint in Curb and Gutter, and General Note 1. FDOT Standard Specifications: Section 520-6 Joints. System is not performing as intended.	CG1, CG2, CG3, CG4
105	Clubhouse: Entrance Near Sauvignon Parkway, Curb Cedarbrook: Roundabout Near 17321 Ponte Chiasso Drive, Curb	Crack(s).	Deviation / Defect	Curb and Gutter	FDOT Design Standards: Index 300, Sheet 2 of 2, Contraction Joint in Curb and Gutter, and General Note 1. FDOT Standard Specifications: Section 520-6 Joints. System is not performing as intended.	CG5, CG6, CG7, CG8

Location: Clubhouse: Entrance Near Sauvignon Parkway, Curb

Remarks: Crack(s).

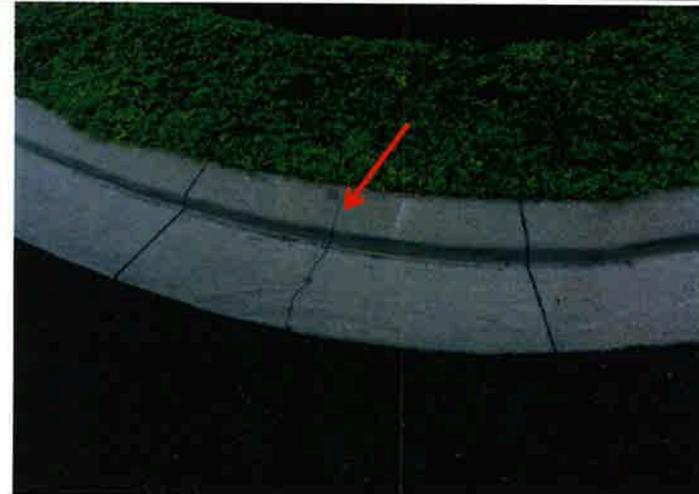
Photo No. CG 8

Location: Cedarbrook: Roundabout Near 17321 Ponte Chiasso Drive, Curb

Remarks: Crack(s).

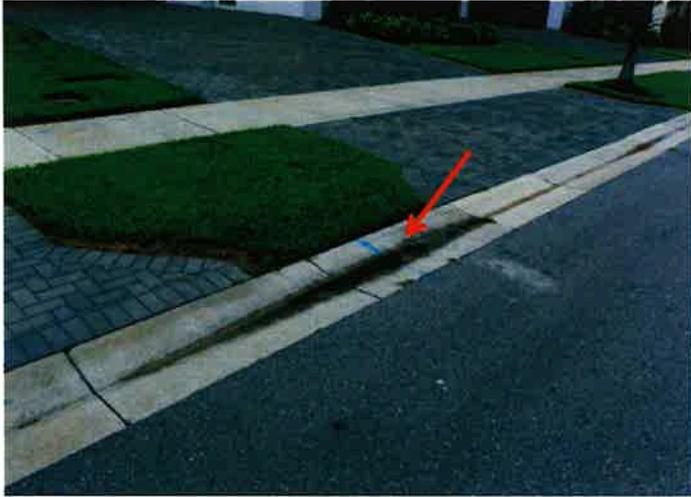
Photo No. CG 9

Line #	Location Description	Observation	Code Violation, Defect, Deviation, Improper Preturover Maintenance	Potential Attributable Scope of Work	Criterion and Notes	Typical Photo
106	<p>Cambridge: 17413 Rosella Road, Gutter</p> <p>Waldorf: 8997 Chauvet Way, Gutter</p> <p>Rosewood: 9119 and 9101 (Typical Photo) Benedetta Place, Gutter</p>	Ponding water evident.	Deviation / Defect	Curb and Gutter	<p>FDOT Greenbook, Chapter 3, Section C.5.b Grades, Table 3 - 7, Recommended minimum gutter grades: Flat terrain - 0.3%.</p> <p>Plans: Paving, Grading, and Drainage, Plat 3, Sheet 6. Plans indicate stormwater flow to slope towards drain.</p> <p>Plans: Paving, Grading, and Drainage, Plat 1, Sheets 8 and 12. Plans indicate stormwater flow to slope towards drain.</p> <p>Finish grade should slope towards provided drain.</p>	CG9, CG10

Location: Rosewood: 9101 Benedetta Place, Gutter

Remarks: Ponding water evident.

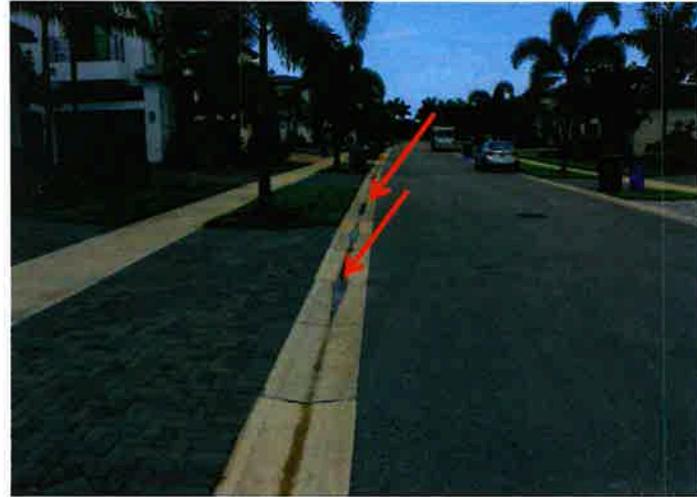
Photo No. CG 10

Location: Rosewood: 9101 Benedetta Place, Gutter

Remarks: Ponding water evident.

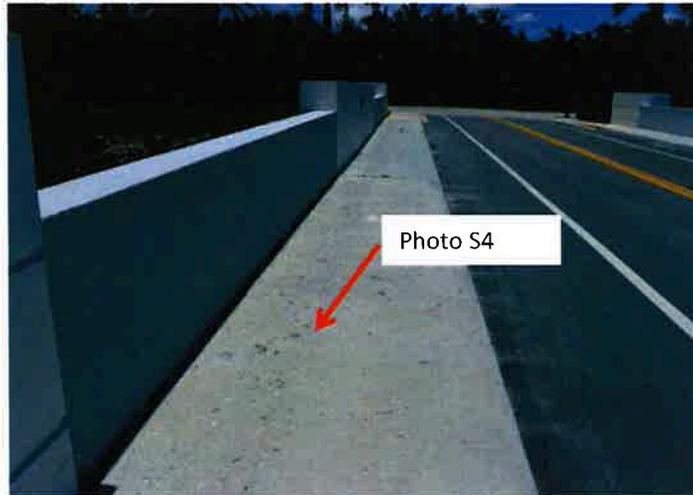
Photo No. S 3

Line #	Location Description	Observation	Code Violation, Defect, Deviation, Improper Preturndover Maintenance	Potential Attributable Scope of Work	Criterion and Notes	Typical Photo
107	<p>Pro Shop: Sidewalk (Multiple Locations) (Typical Photo: Near the North Tennis Courts)</p> <p>Clubhouse: Near Playground, Sidewalk</p> <p>Clubhouse: Near Mechanical Enclosure to Mechanical Room 1, Sidewalk</p> <p>Clubhouse: Near 24 Hour Fitness Entrance, Sidewalk</p> <p>West Guardhouse: Bridge, Sidewalk (Typical Photo)</p> <p>Cambridge: 17418 (Typical Photo) and 17471 Rosella Road, Sidewalk</p> <p>Biltmore: 9658 Chianti Classico Terrace, Sidewalk (Typical Photo)</p> <p>Brookside: Bridge, Sidewalk</p> <p>Brookside: 9609 Ristretto Trail, Sidewalk</p>	Crack(s).	Deviation / Defect	Sidewalk	<p>FDOT Design Standards: Index 310, Sheet 1 and 2, Sidewalk Joints.</p> <p>FDOT Standard Specifications: Section 522-4 Foundation and 522-5 Joints.</p> <p>System is failing prematurely and is not meeting its service life.</p>	S1, S2, S3, S4, S5, S6, S7, S8

Location: West Guardhouse: Bridge, Sidewalk

Remarks: Crack(s).

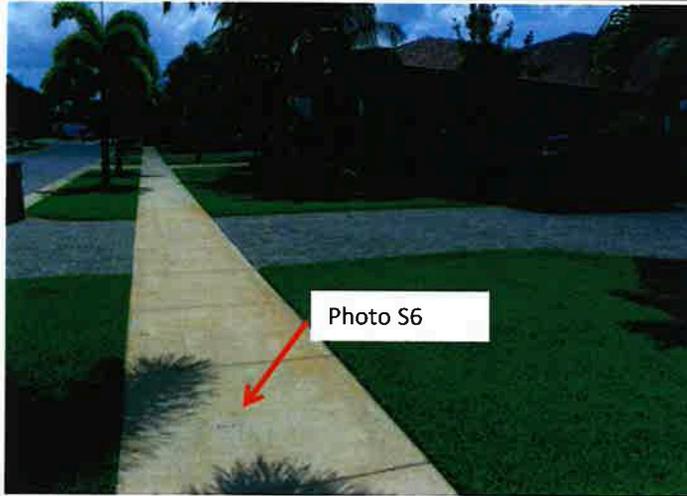
Photo No. S 5

Location: Cambridge: 17418 Rosella Road, Sidewalk

Remarks: Crack(s).

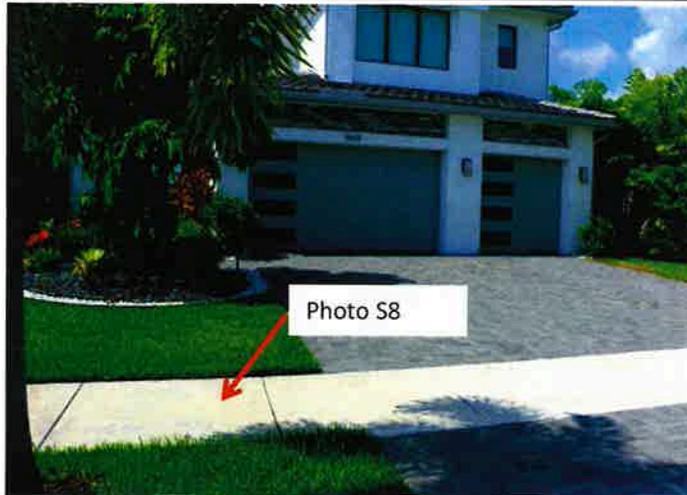
Photo No. S 7

Location: Biltmore: 9658 Chianti Classico Terrace, Sidewalk

Remarks: Crack(s).

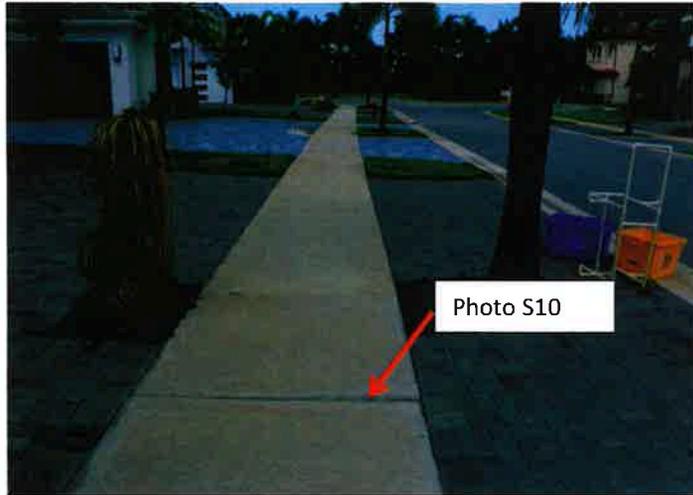
Photo No. S 9

Location: Rosewood: 9071 Benedetta Place, Sidewalk
Remarks: Elevation difference greater than 1/4 inch. Tripping hazard evident.

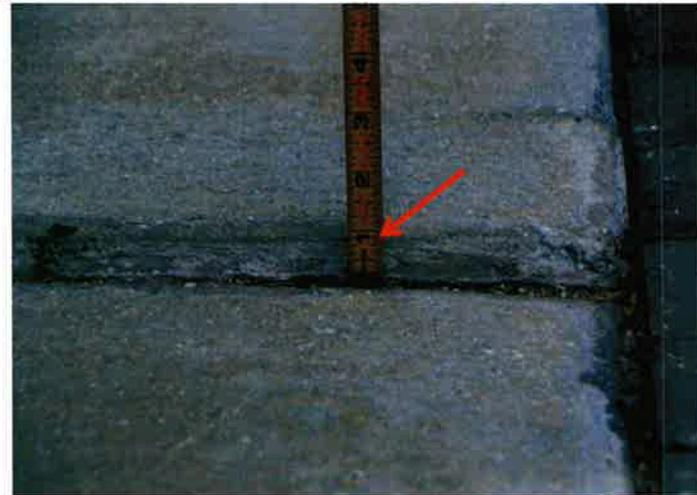
Photo No. S 10

Location: Rosewood: 9071 Benedetta Place, Sidewalk
Remarks: Elevation difference greater than 1/4 inch. Tripping hazard evident.

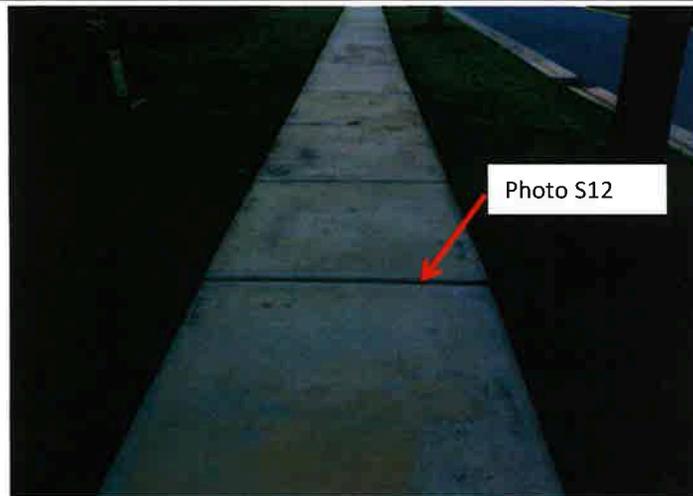
Photo No. S 11

Location: Brookside: 17378 Ristretto Trail, Sidewalk
Remarks: Elevation difference greater than 1/4 inch. Tripping hazard evident.

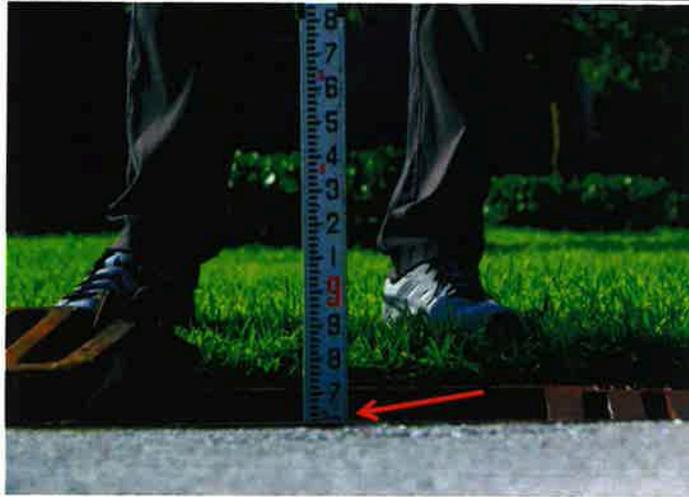
Photo No. AD 5

Location: Brookside: Near 9577 Vescovato Way, Drain

Remarks: Excessive sediment observed in catch basins.

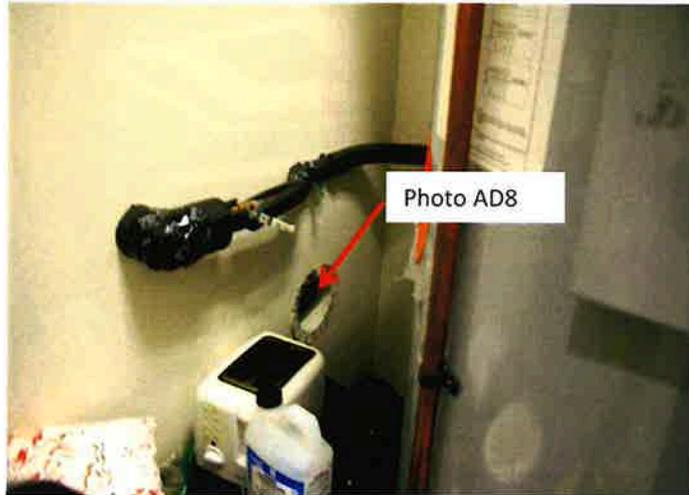
Photo No. AD 7

111	Women's Locker Room: Mechanical Closet	Unsealed penetration.	Code Violation	Fire Protection	2017 FBC - Building, Section 714.3.1. 2017 FBC - Building, Section 714.4 Horizontal Assemblies.	AD7, AD8

Location: Women's Locker Room: Mechanical Closet

Remarks: Unsealed penetration.

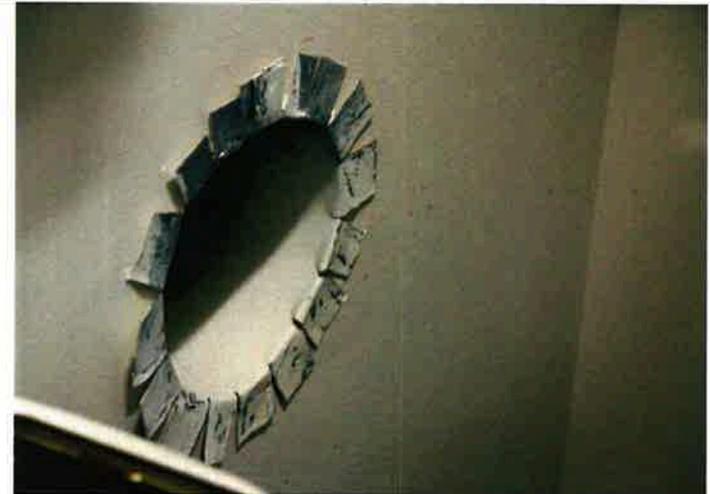
Photo No. AD 8

Location: Women's Locker Room: Mechanical Closet

Remarks: Unsealed penetration.

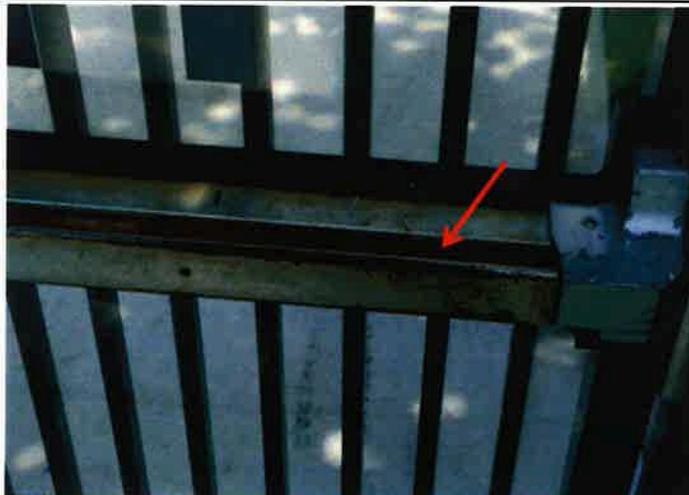
Photo No. AD 13

Location: Clubhouse: East Side, Near Basketball Court, Gate

Remarks: Finish failure evident.

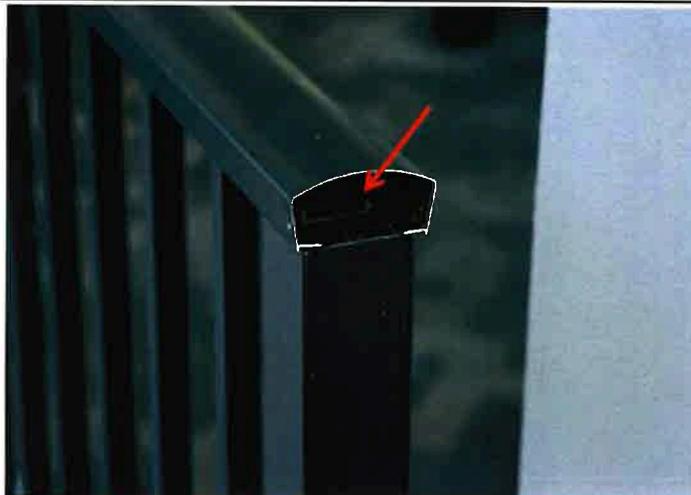
Photo No. AD 21

Location: Clubhouse: Pavilion, Fence

Remarks: Railing end cap is missing.

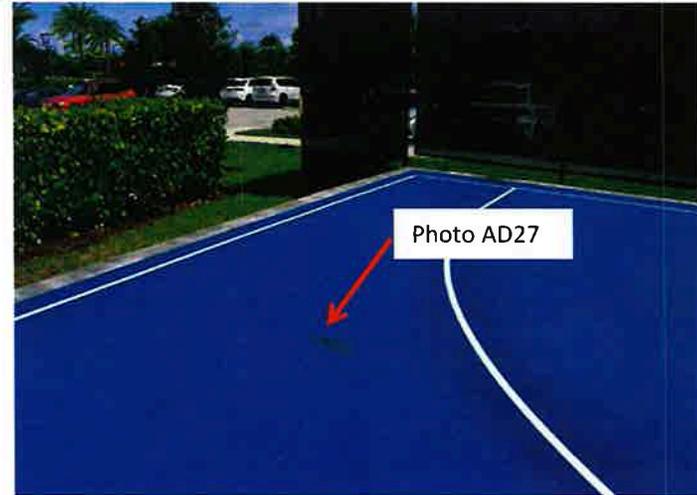
Photo No. AD 26

Location: Clubhouse: Outdoor Basketball Court

Remarks: Rust stains.

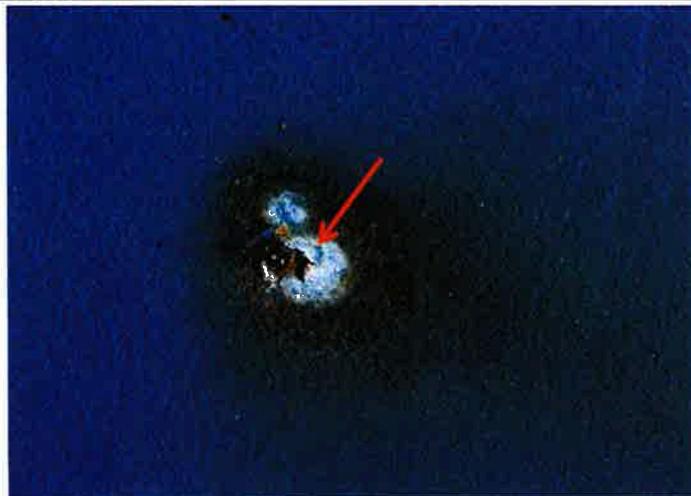
Photo No. AD 27

Location: Clubhouse: Outdoor Basketball Court

Remarks: Rust stains.

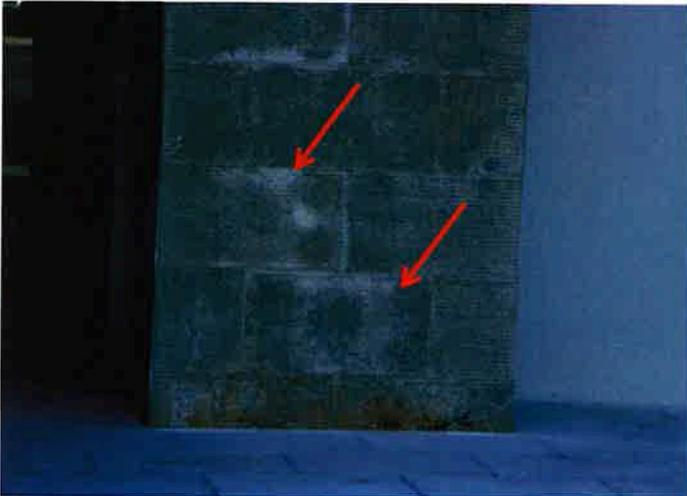
Photo No. AD 31

Location: Clubhouse: Near Entrance Doorway to Café / Take Out, Wall, Stone Cladding

Remarks: Efflorescence evident.
